*Belzona Solutions for Machinery &  
Equipment Brochure*

# Belzona Solutions for Machinery & Equipment

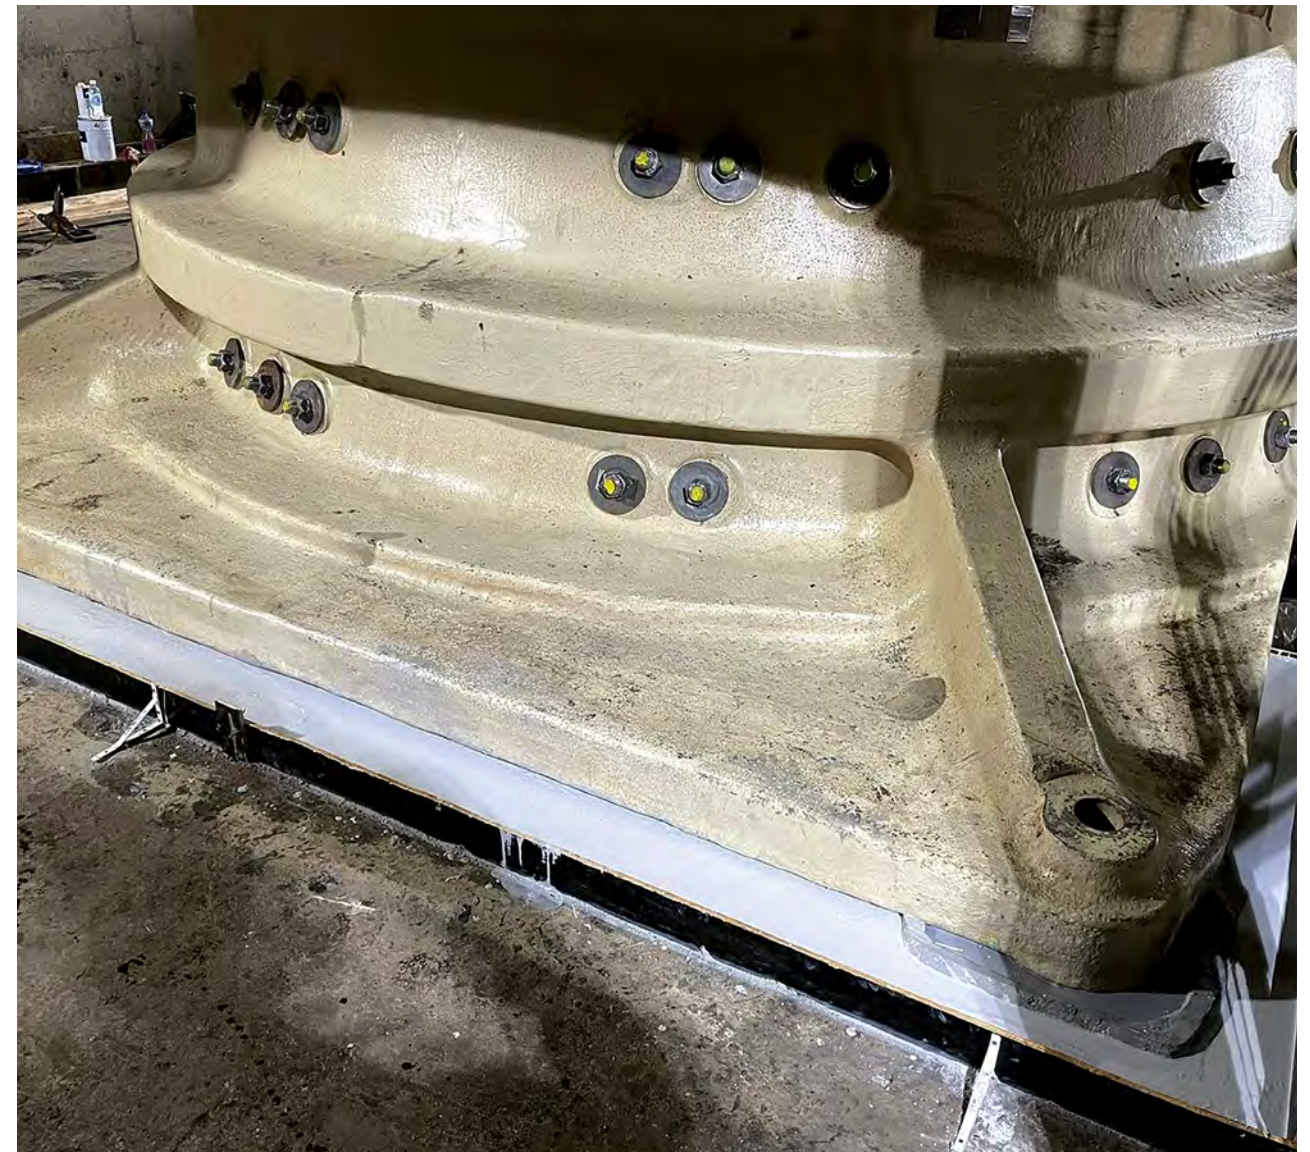
*A crusher base stabilized using Belzona anchoring solutions*

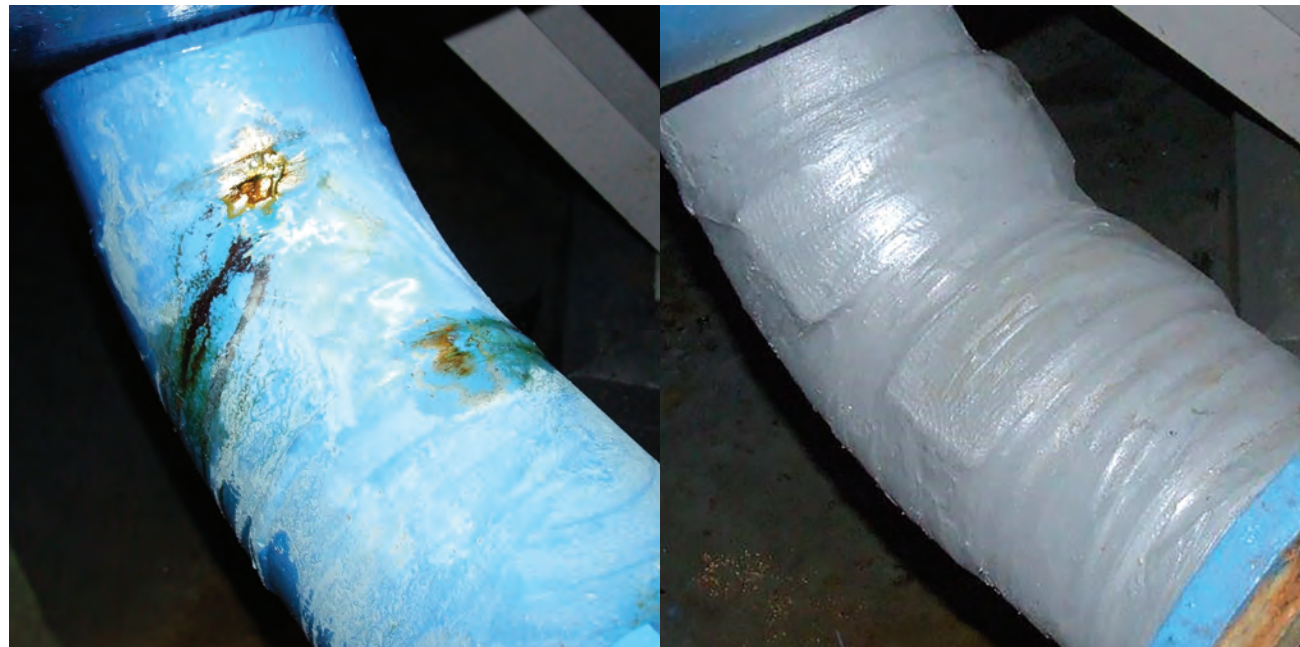
*Internal corrosion resulting in pin hole leaks*

*Plate bond and wrap repair on pipe*

Two welded areas on this pipe had experienced internal corrosion resulting in pin hole leaks. Traditional cutting and welding methods were unsuitable in this Pharmaceutical Plant due to environmental constraints and stringent safety regulations. In addition, these methods would not prevent future corrosion. The cold applied, Belzona metal repair solution was chosen as it is solvent free, reducing health and safety risks. Installed and cured using external heat, it minimized downtime and ensured long-lasting protection. As a result, the Belzona solution extended the equipment's lifespan by preventing future corrosion. This repair demonstrated its reliability and effectiveness in service for over five years, showcasing its superior performance against traditional repair methods.

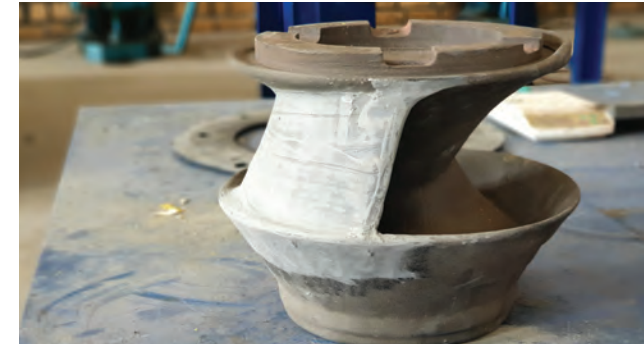
*Eroded pump impeller repaired and protected*

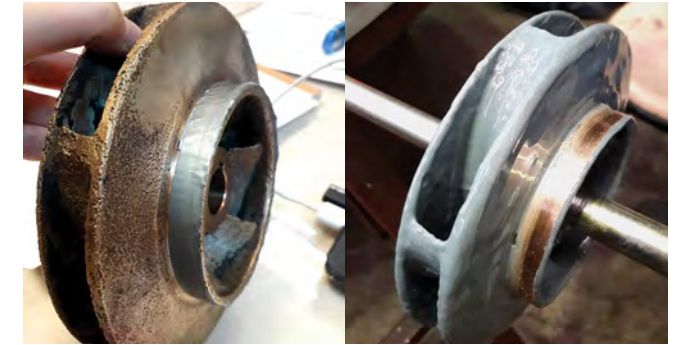
*Pump impeller rebuilt and protected from erosion-corrosion*

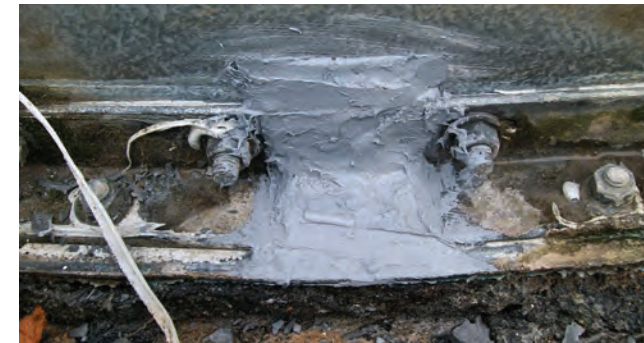
*Tank base causing local flooding sealed*

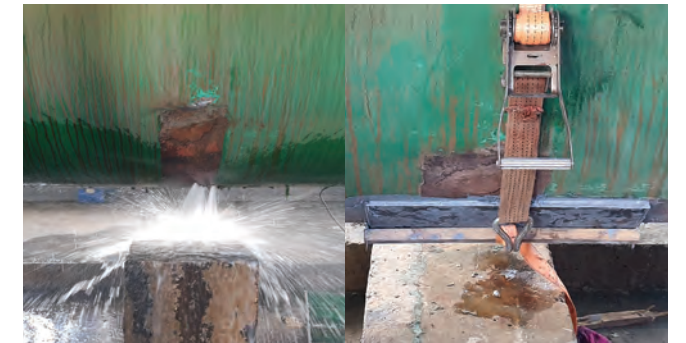
*Live leak on a pipe sealed with Belzona*

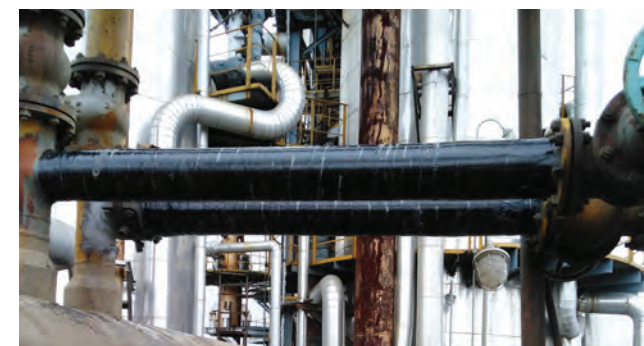
*Pipe wall strength restored using compliant pipe wrap*

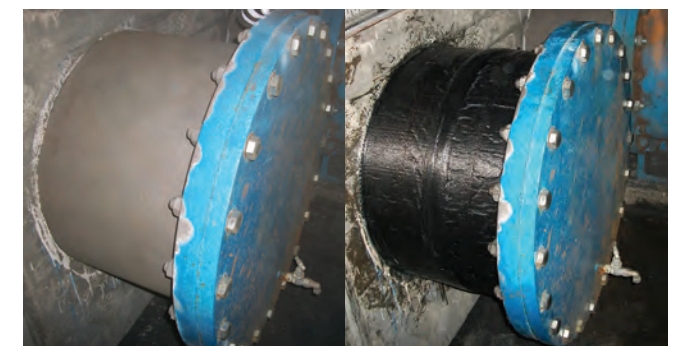
*Wrap repair on pipework*

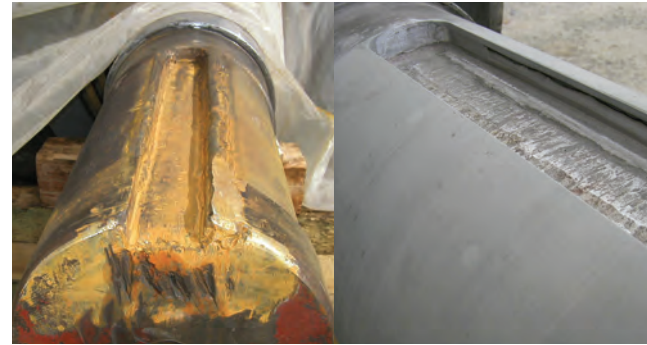
Jaw crusher's damaged shaft and keyway repaired

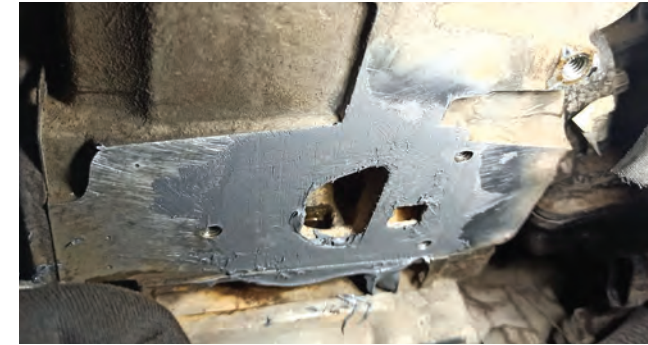
Engine block leaking coolant repaired

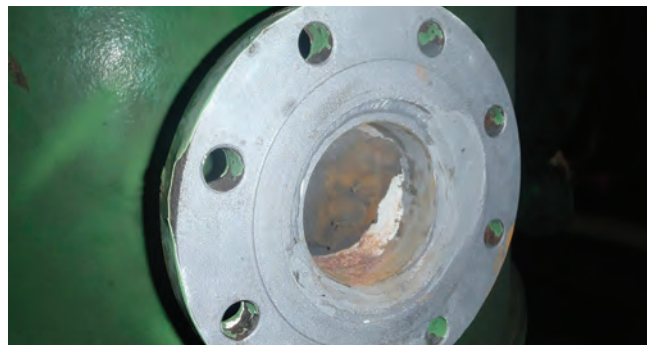
Flange face after grit blasting and deep pitting

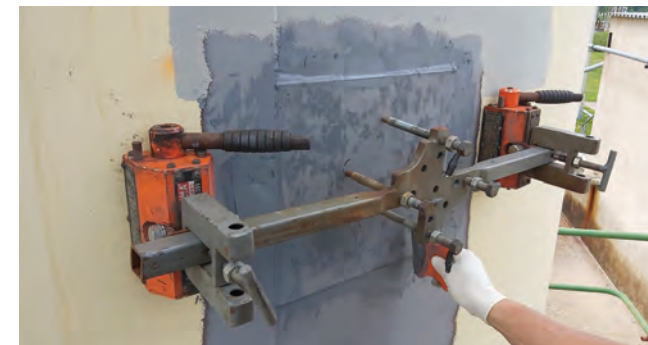
Corroded tank wall repaired

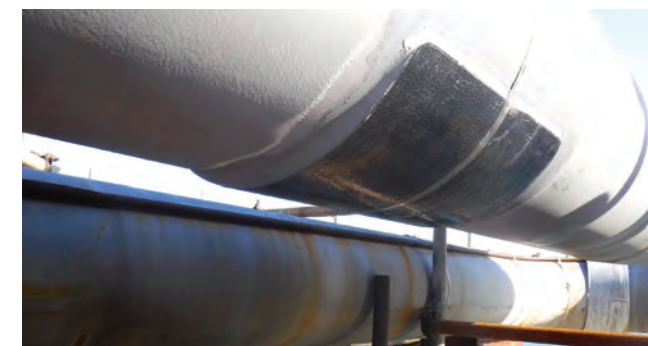
Composite pad installed for pipeline repair

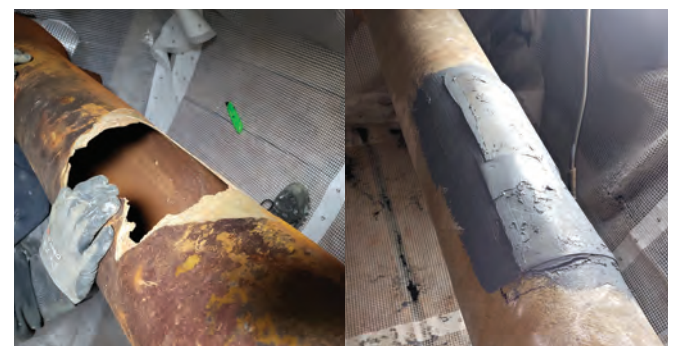
Damaged GRP pipe repaired using Belzona's cold bonding solution

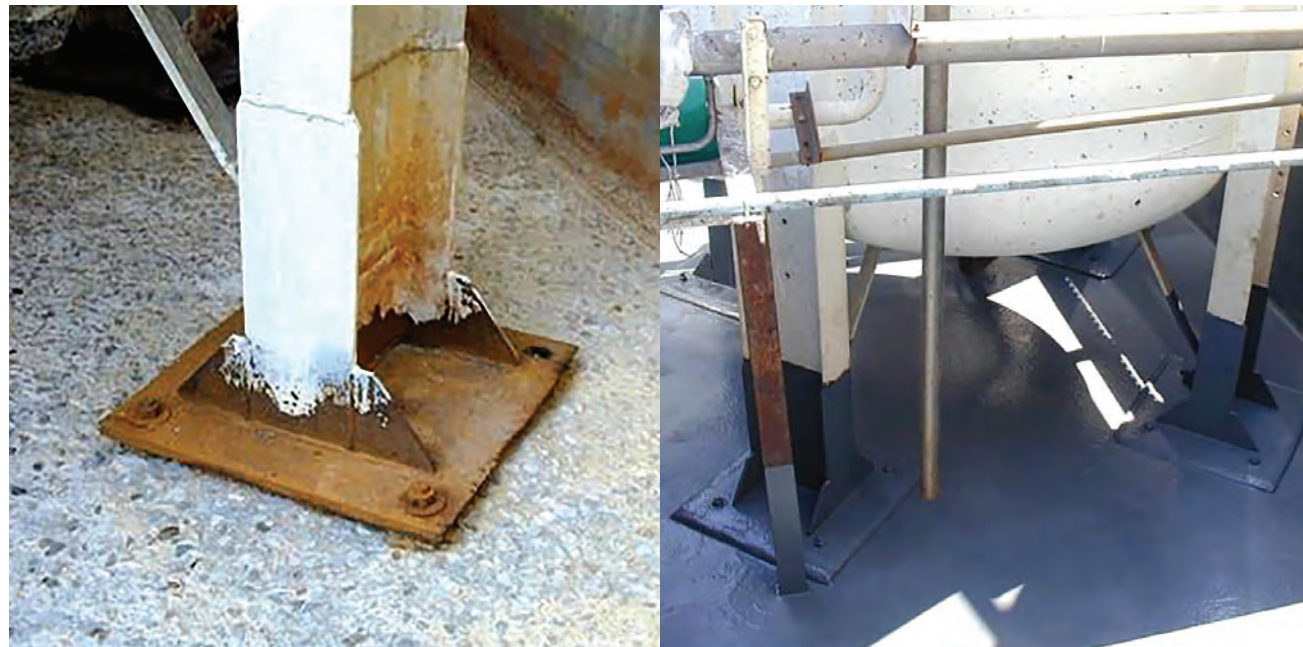
*Deterioration of the concrete due to leakage and contamination      Shimming and protecting base of support steelwork*

The concrete had suffered heavy deterioration due to leakage and contamination during maintenance operations, compromising the integrity of the structure. The repair was conducted in accordance with Belzona Know-How System Leaflet TCC-15, with special attention given to shimming and protecting the base of the support steelwork. The area was brought up to standard to meet the required regulations, and additional protection was provided for the supports. Repairs can be easily carried out if needed. During the last inspection in 2009, the containment area was found to be in perfect condition, demonstrating the durability of the solution.

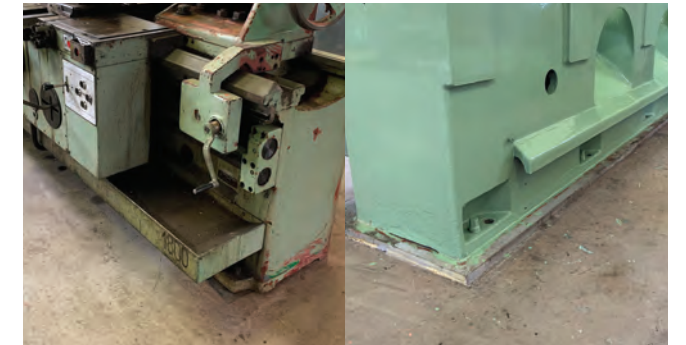
*Installed lathe required chocking for stabilization*

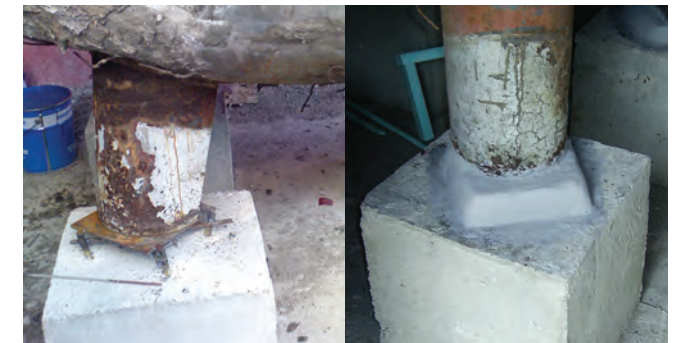
*Vessel supports repaired and protected*

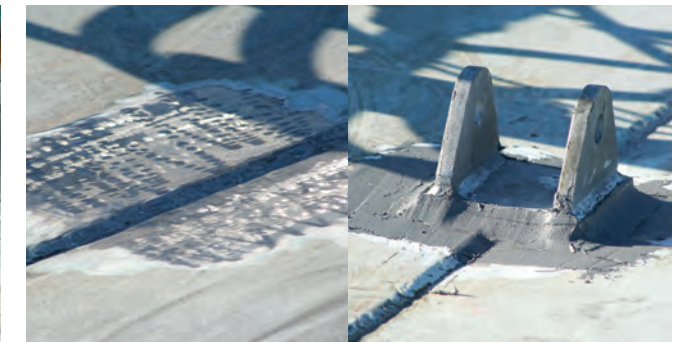
*Plates bonded on top of a water tower for radio dishes*

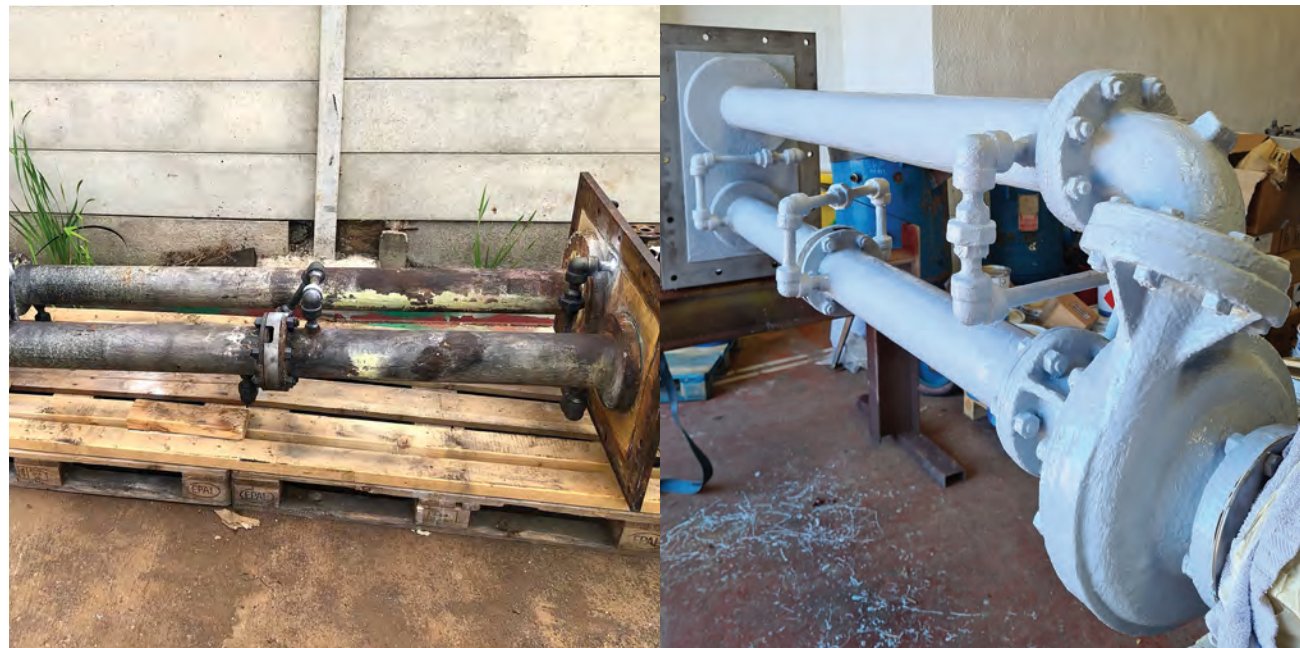
*Short working life of pumps due to high corrosion*

*Pumps coated to provide long-term protection*

Since 1997, Belzona 1591 has been used to coat many pumps in a sulfur pit. Corrosion spots began to appear on the internal equipment of the sulfur pit, necessitating protection from further damage. The surface was grit blasted to achieve a cleanliness level of Sa2½ before applying two coats of Belzona 1593 to provide outstanding corrosion protection. This application followed Belzona Know-How System Leaflets VPF-2. The pump, originally coated in 2017, was revisited in 2022, and the coating showed minimal damage. The Customer opted for a full recoat, although a small repair would have sufficed. The pumps, inspected five years later, displayed minimal damage.

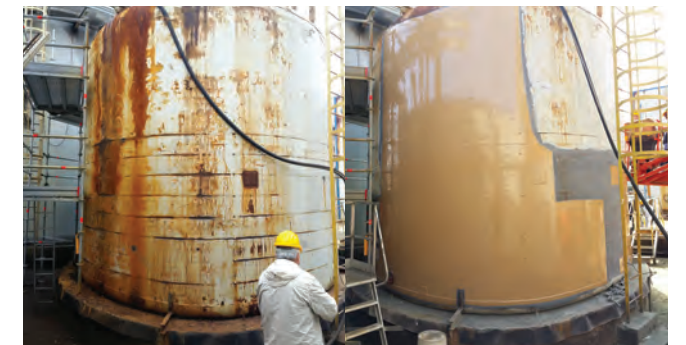
*External corrosion protection on tank*

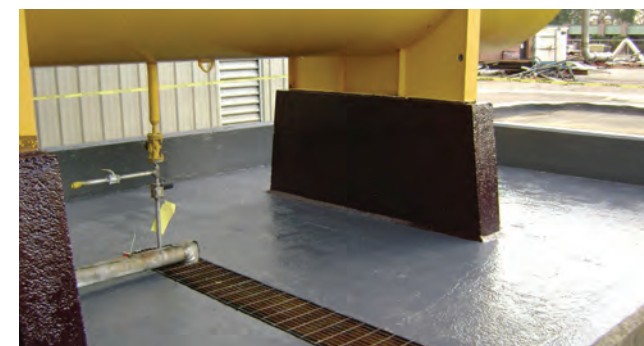
*Sulfuric acid containment area coated and protected*

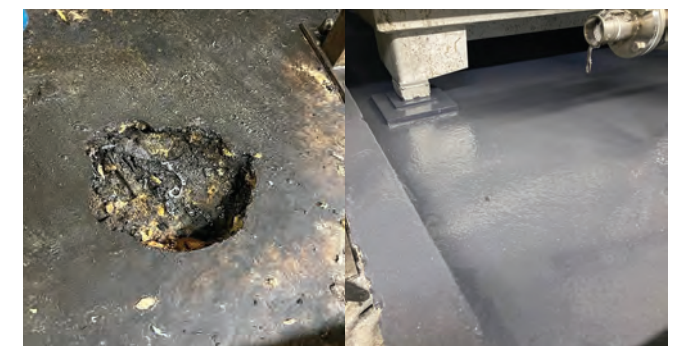
*Corroded concrete repaired and protected from chemical attack*

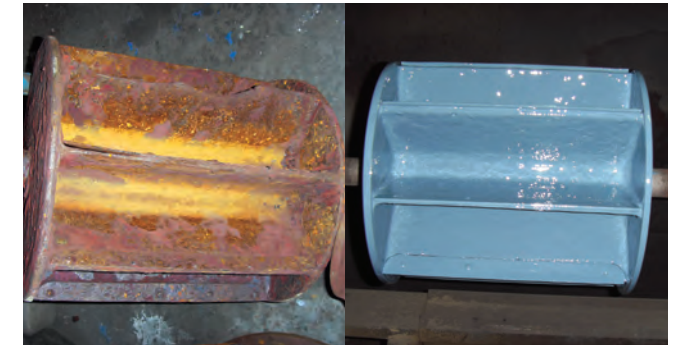
*Vacuum pump rotor repaired and protected*

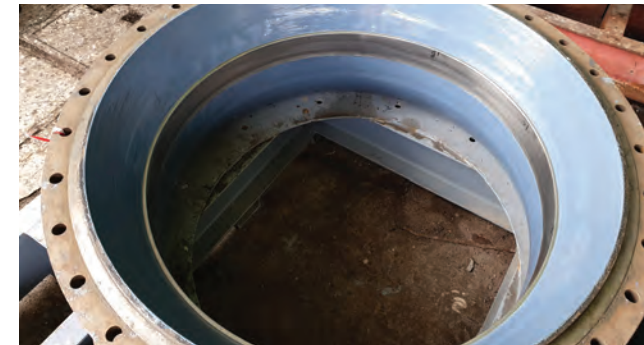
*Valve repaired and protected from sea water erosion*

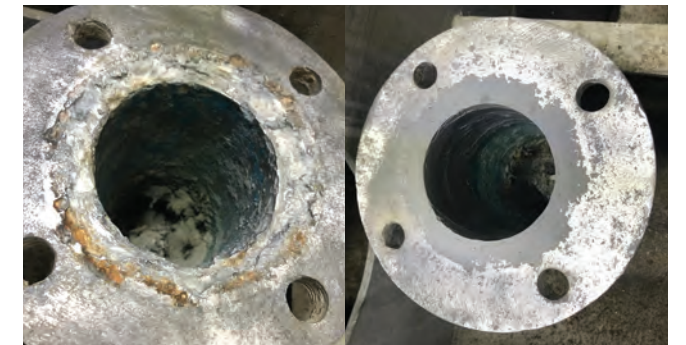
*Emergency flange repair*

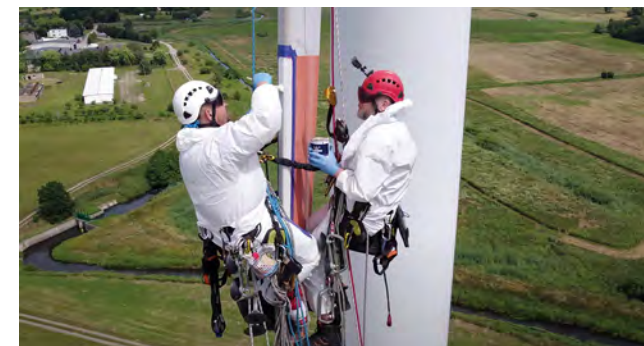
*Protection of wind turbine blades*

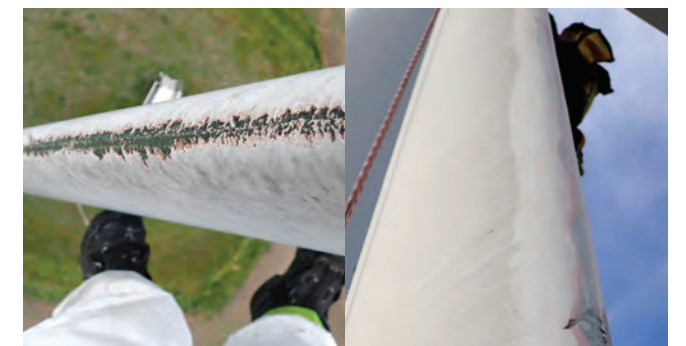
*Rain erosion repaired with Belzona leading edge protection solutions*

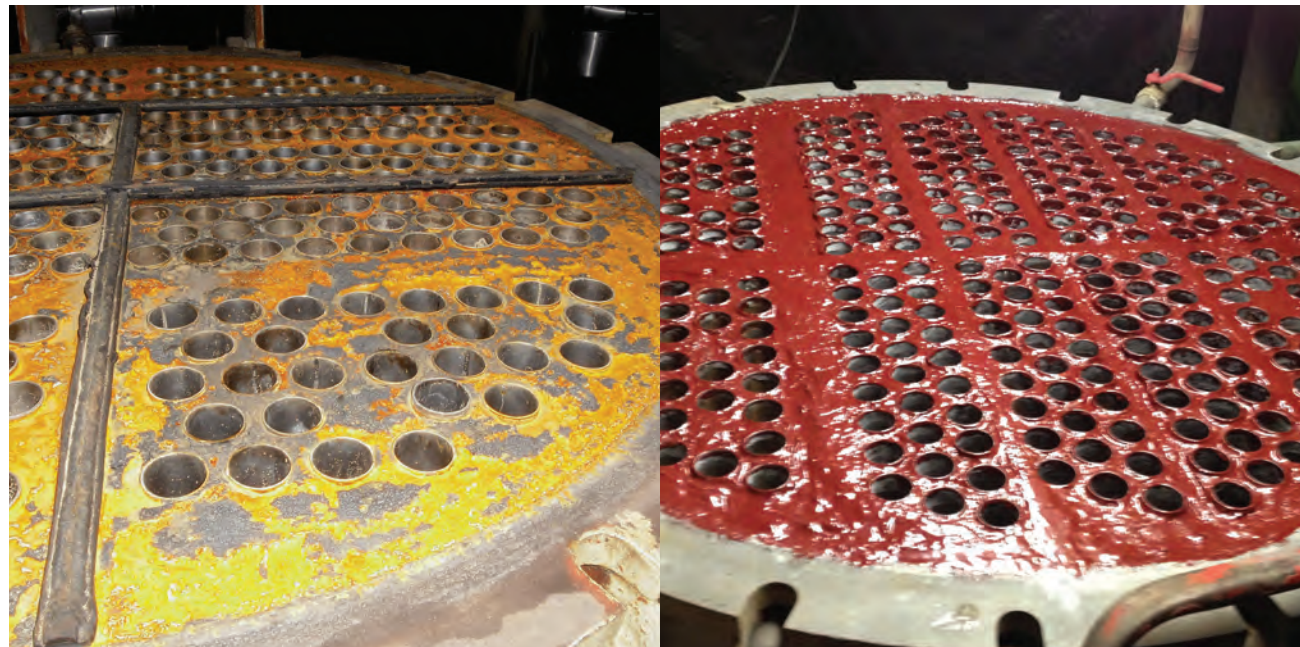
*Degradation of surface due to high temperature acidic media*

*Heat exchangers repaired and protected*

Severe corrosion and erosion had affected both ends of two heat exchangers, with surface degradation caused by high-temperature, aggressive acidic media. The repair was carried out according to Belzona Know-How System Leaflets HEX-1 and HEX-3. The Customer was in the process of obtaining quotes for new heat exchangers, but Belzona offered a lower-cost alternative with minimal delay and disruption to production. The Belzona solution has provided excellent protection, and after three years in service, the repair was reinspected and still performing exceptionally well.

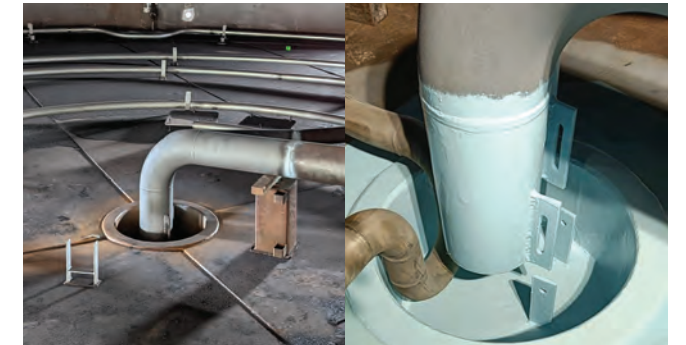
*Storage tank protected against high temperatures*

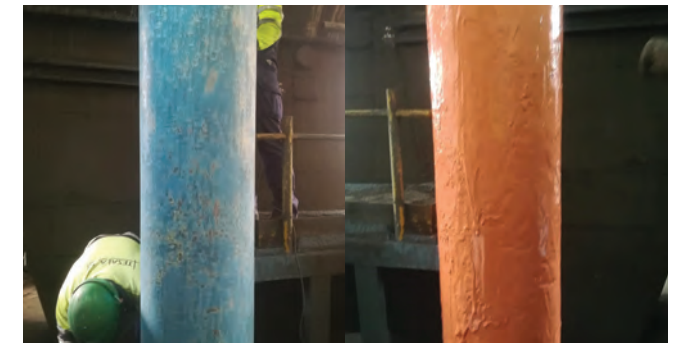
*Exposed hot pipeline made safe with insulation*

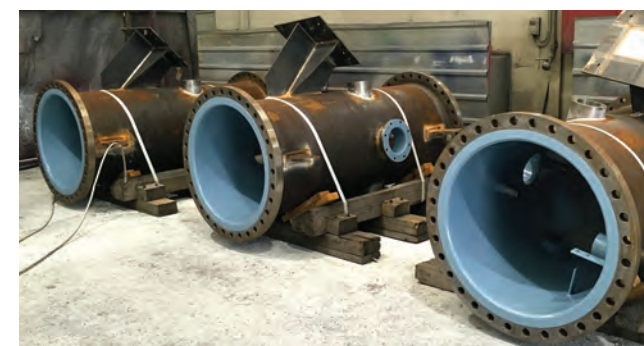
*High temperature corrosion protection for new water filters*

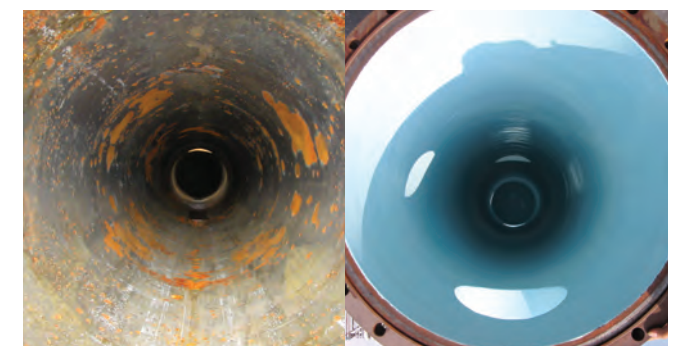
*Desulfurization unit protected with coating*

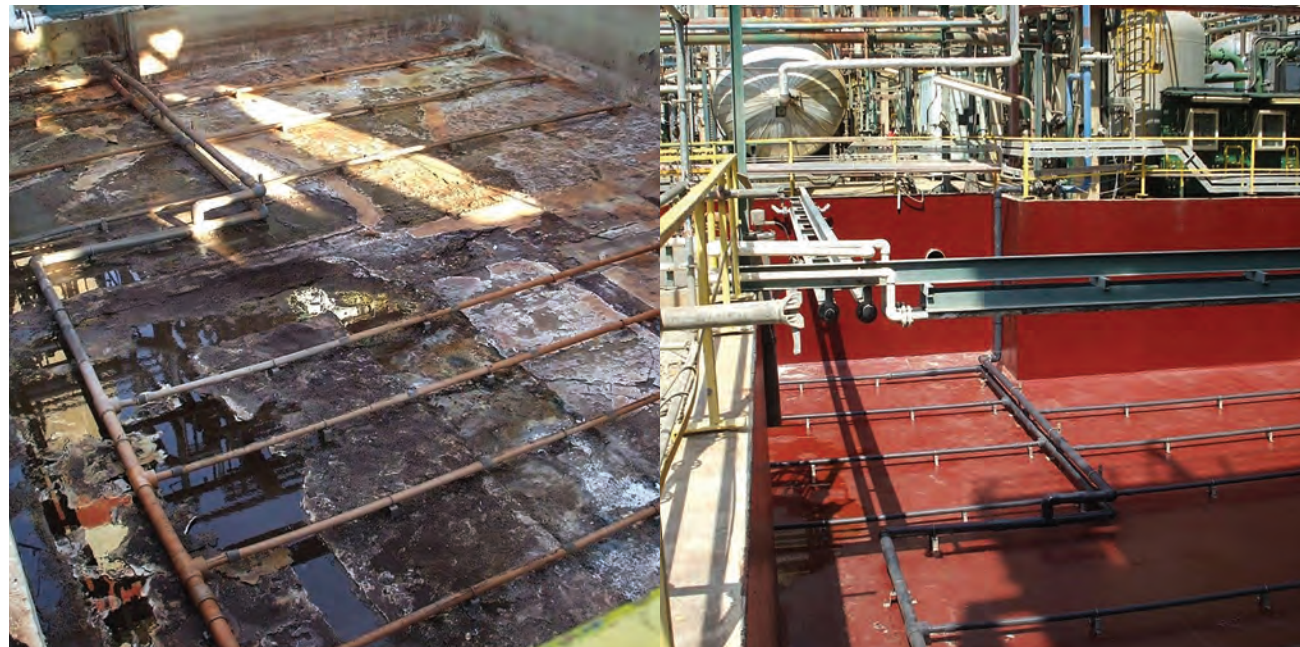
*Severe damage to the coating and concrete from chemicals*

*Two years after applying the protective coating*

A chemical neutralization bund in a Refinery contained sulfuric acid at a 90% concentration and sodium hydroxide at a 50% concentration, with temperatures reaching up to 176°F (80°C). The application followed Belzona System Leaflet TCC-15. Initially, the concrete was cleaned with high-pressure water jetting to remove the existing coating and contaminants from the substrate. The surface was then grit blasted using metallic grit, and Belzona 4981 was applied to ensure excellent adhesion. Finally, a two-coat system of Belzona 4341 (Magma CR4) was applied to form a protective barrier. A previous coating had failed after a short time in service, so the Customer needed a long-lasting coating to prevent concrete degradation and potential spillages into the ground. Having had positive experiences with Belzona solutions for various applications, including pumps, composite patches, and composite pipe wraps, the Customer was confident in Belzona's ability to deliver an effective solution. After 1.5 years in service, the area was revisited and found to be in excellent condition.

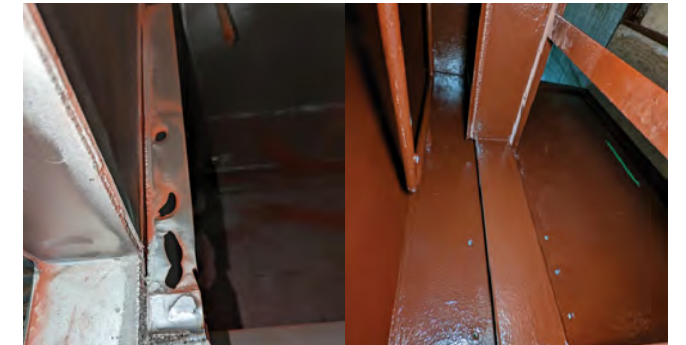
*Scrubber vessels coated to protect from chemical attack*

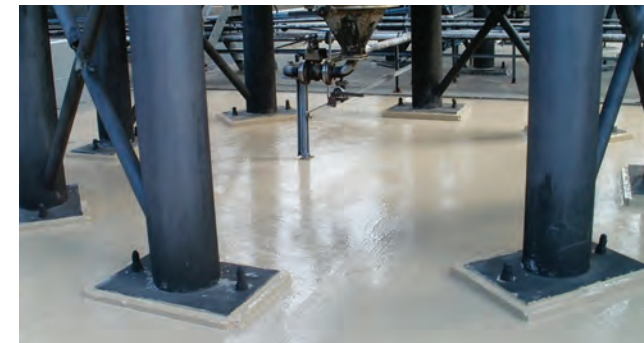
*Spirit containment area repaired and protected*

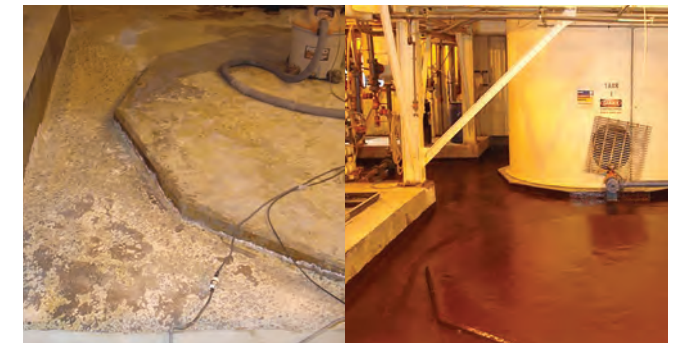
*Concrete was rebuilt and protected from sulfuric acid damage*

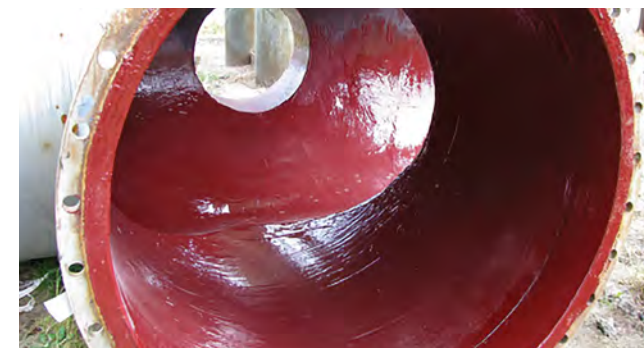
*Internal lining protected against chemical attack*

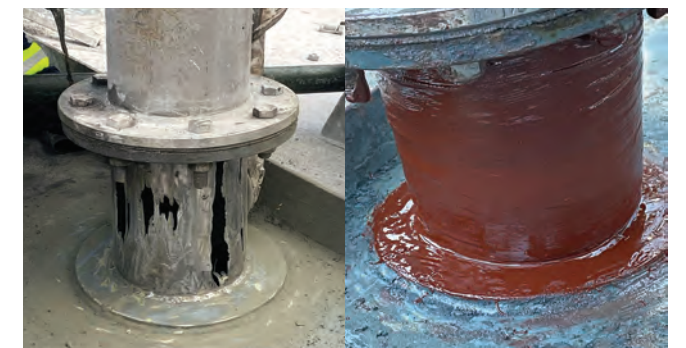
*Damaged acid intake nozzle rebuilt*

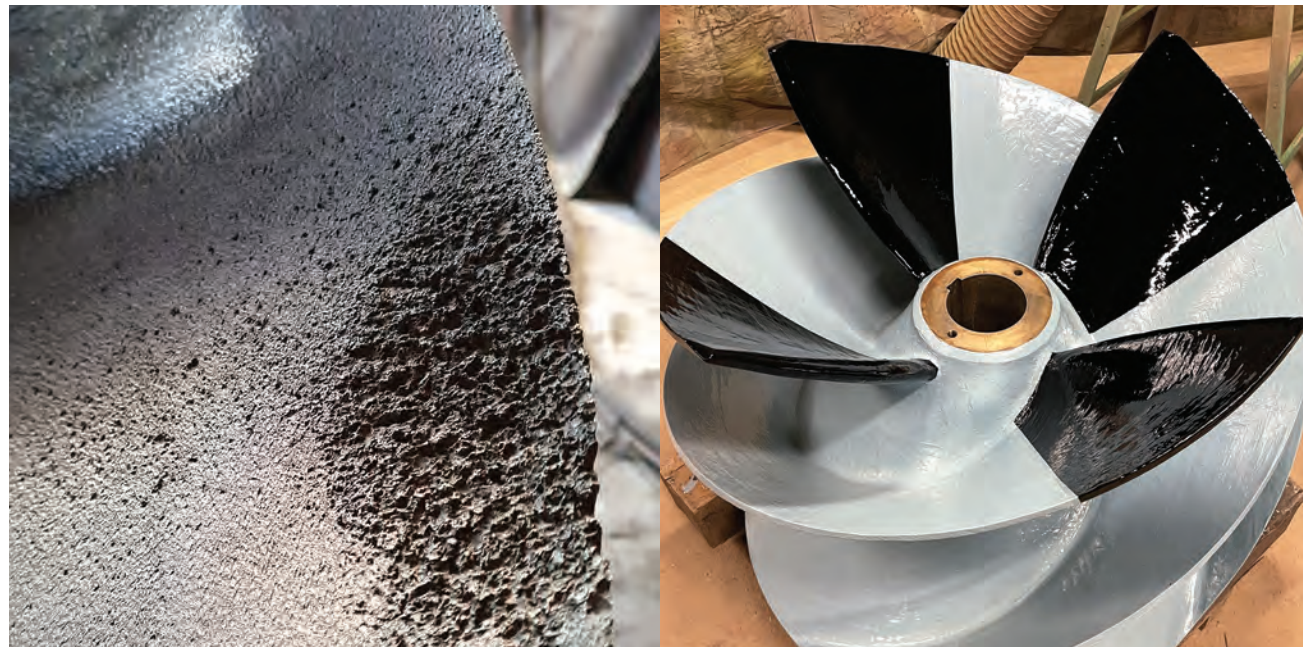
*Cavitation damage*

*Impeller coated to protect against future cavitation*

During a planned overhaul, severe cavitation was detected on one of the main cooling pumps at a Nuclear Power Plant. This damage, if left unaddressed, could lead to operational inefficiencies and potential shutdowns. The pump's impeller was grit blasted and the cavitation damage was rebuilt to its original profile using Belzona 1111 (Super Metal), a durable metal repair composite. The entire surface of the impeller was then coated with Belzona 1341 (Supermetalglide), an efficiency enhancement protective coating. Specific cavitation impact zones received an additional layer of Belzona 2141 (ACR-Fluid Elastomer) which is designed to withstand the forces of cavitation.

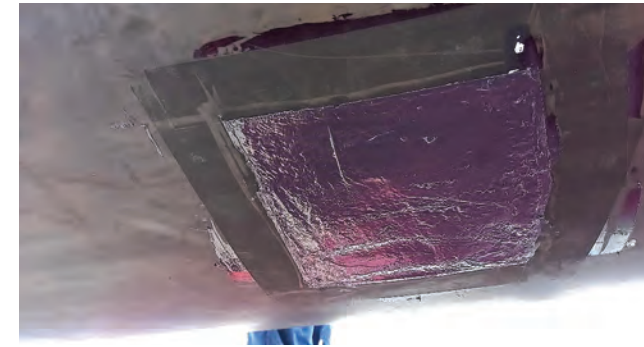
*Repaired 4km long conveyor belt back in operation*

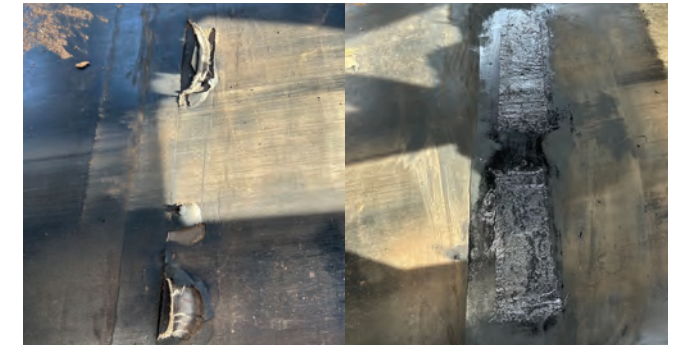
*Damaged conveyor belt at a paper mill repaired*

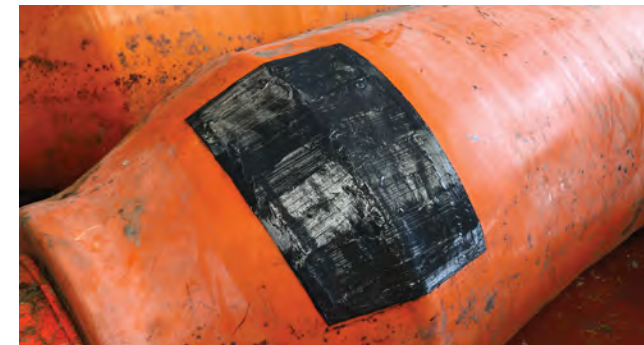
*Rubber covers on fuel hoses repaired*

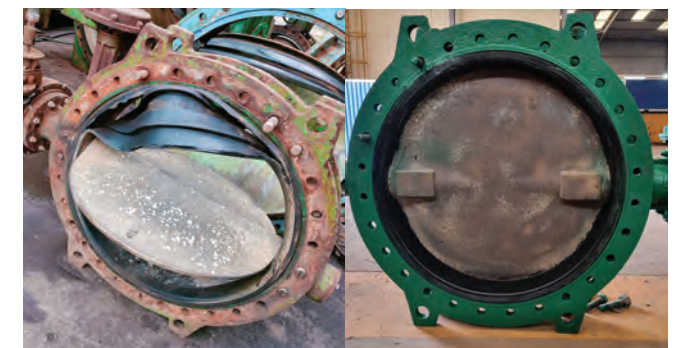
*Butterfly valve rubber repaired*

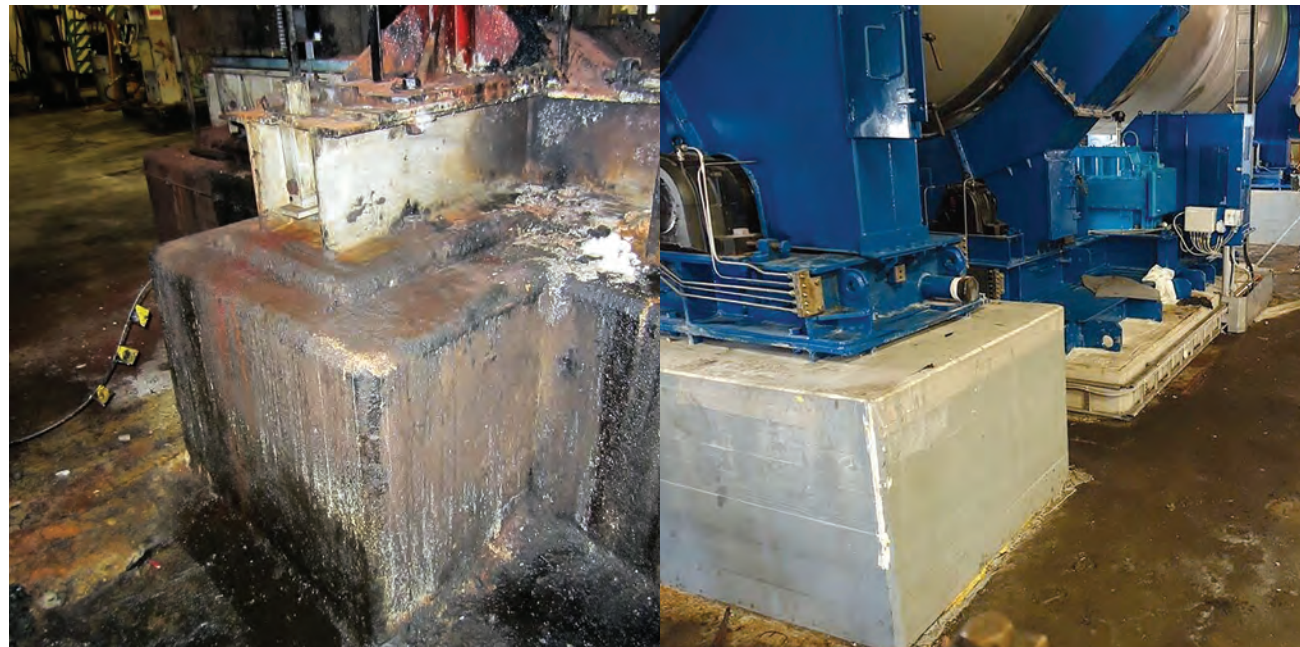
*Damaged concrete plinths*

*Concrete rebuilt and restored for new machinery*

A 50-year-old fertilizer plant in Sweden needed to install new machinery, but its existing concrete plinths were severely corroded and damaged. Traditional concrete repairs were not an option due to long curing times that would delay the project. Instead, Belzona provided a fast and durable solution using its high-performance epoxy repair composites. The application involved surface preparation, rebuilding the damaged areas, and applying a protective coating to ensure long-term performance. Belzona 4111 (Magma-Quartz) was used for structural rebuilding, while Belzona 4154 (Bulkfill Resin) provided volume filling and reinforcement. This repair method allowed for a quick return to service, preventing costly downtime. Nearly a decade later, the application remains intact, demonstrating Belzona's long-lasting durability. The project highlights the effectiveness of epoxy solutions in industrial environments where speed and reliability are crucial. Belzona's repair materials not only restored the plinths but also extended their lifespan, ensuring continued operational efficiency.

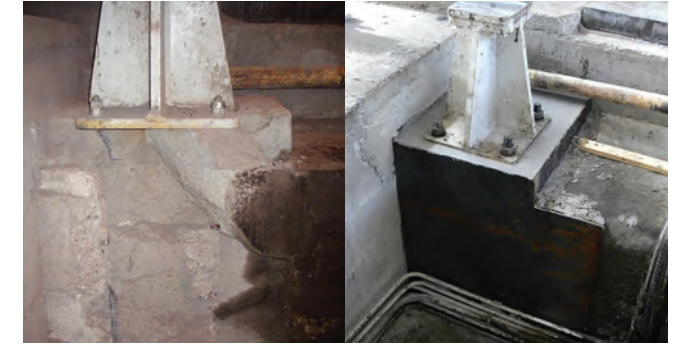
*Damaged concrete footing repaired and rebuilt*

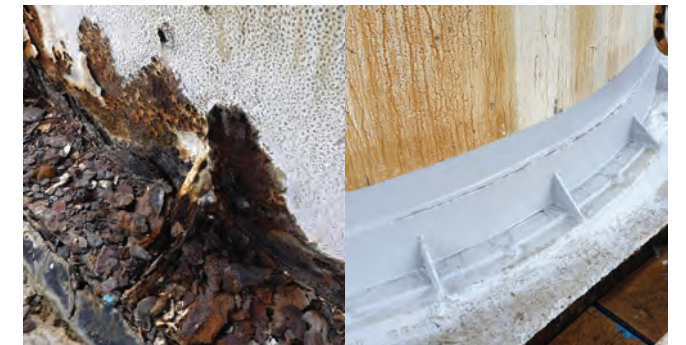
*Tank base repaired and restored from corrosion*

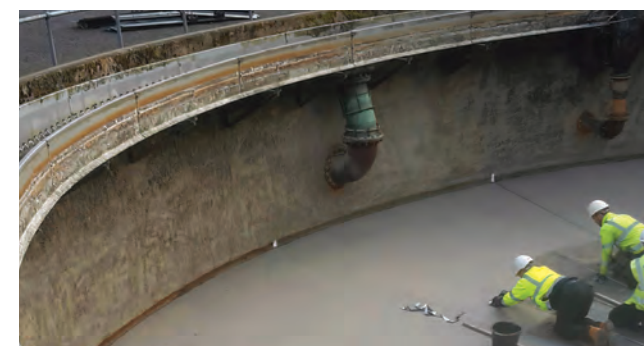
*Repair of a large wastewater clarifier suffering erosion and chemical attack*
