MAINTAINING ASSET INTEGRITY IN THE MARINE INDUSTRY

Belzona Protective Coatings and Engineering Composites

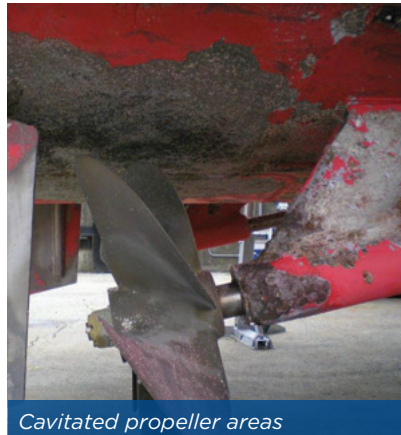
Cavitated propeller areas

Cavitation damage can be repaired without the need for hot work with a Belzona paste grade material. Belzona offers a combination of ceramic epoxy coatings and resilient polyurethane coatings that provides outstanding corrosion and cavitation protection. Our ceramic coatings have a proven track record of increasing efficiency in fluid flow situations, as well as stopping corrosion and significantly slowing down erosion, while the polyurethane coatings are designed to absorb and disperse the cavitation energy, resisting its effects.

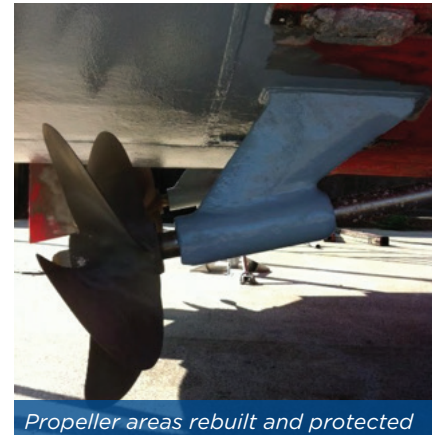
Propeller areas rebuilt and protected

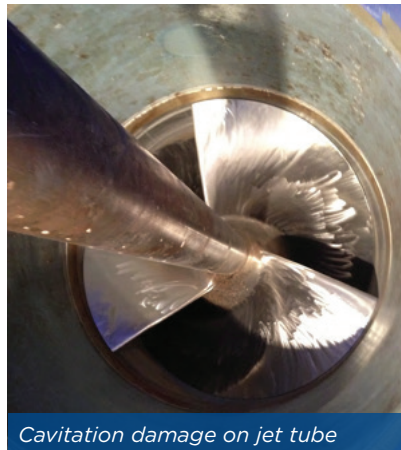
Cavitation damage on jet tube

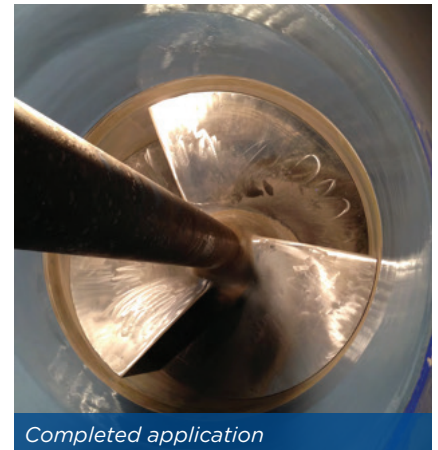
Completed application

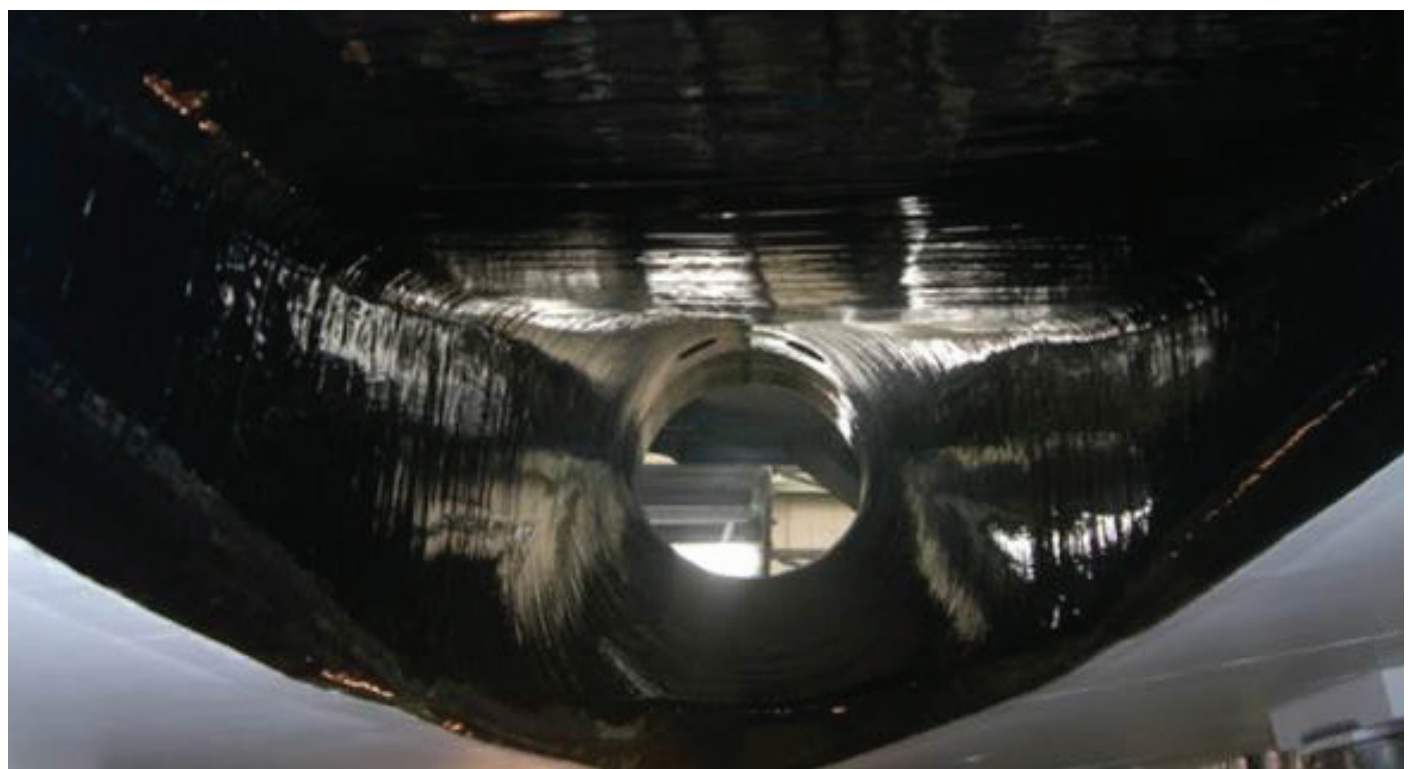
Cavitation protection coating applied to jet tube area on super yacht

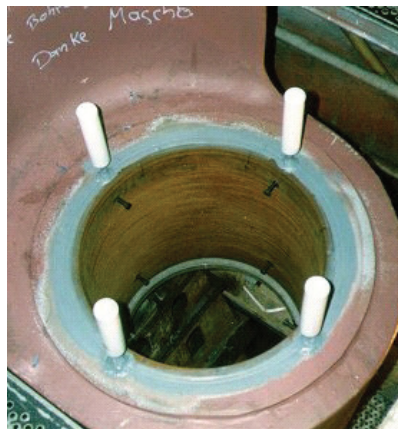
Rudder bearing bonding - top view

The critical requirement with rudder bearings relates to the bush retention in the housing. Corrosion and impact wear can result in the development of annular gaps between the housing and the bearing bush, resulting in a malfunctioning rudder and, consequently, costly repairs and loss of sea time.

The use of Belzona materials for installation of rudder bearings began in 1977 as a collaboration between Belzona and Germanischer Lloyd. The project investigated the use of Belzona materials to eliminate the problem of galvanic corrosion between steel housings and rudder bushes, pintle cones and liners. Nowadays, our polymeric composites and coatings are widely used in the Marine industry for the reseating or installation of new rudder bearings and pintle liners. Our materials allow thickness from 0.1mm to 25mm and demonstrate high adhesion and compressive strength, providing a long-term solution.

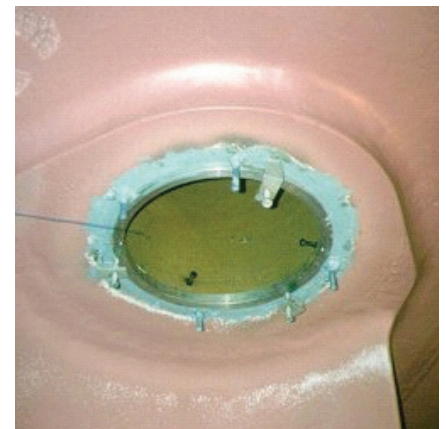
Rudder bearing bonding - bottom view

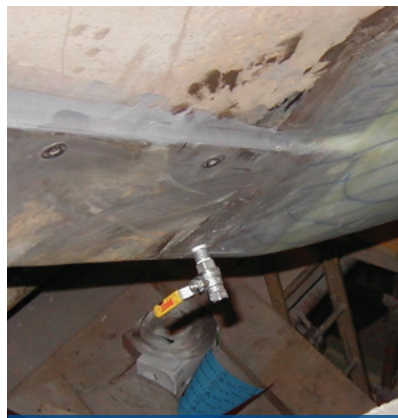
Anchor pocket bonding in progress

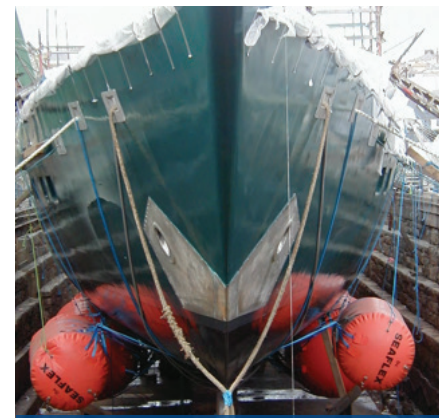
Anchor pocket bonding completed

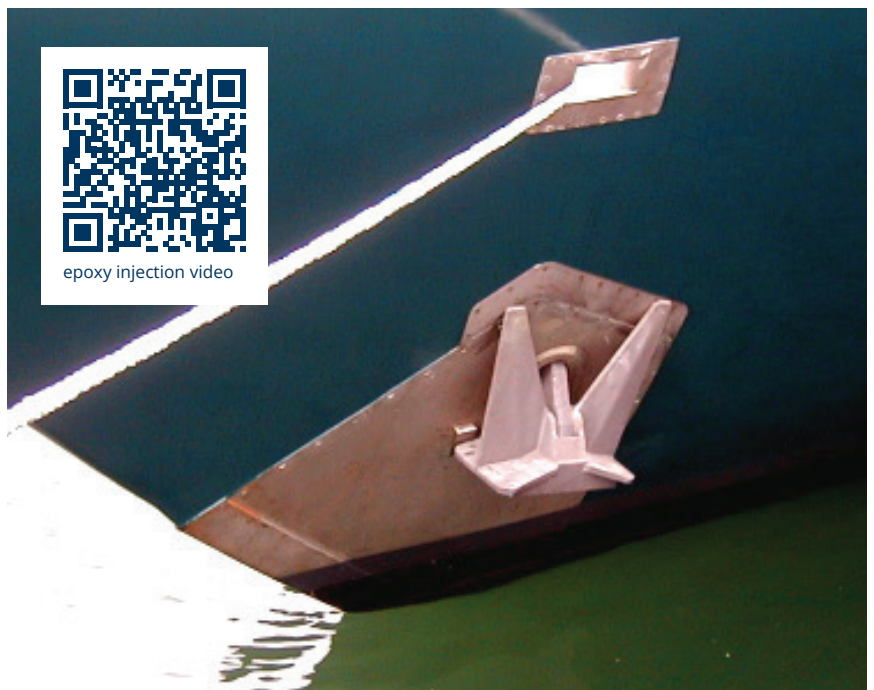
Completed application

Corroded equipment and structures can be repaired with Belzona's pioneering injection bonding technology, helping to restore their structural integrity. This technique has been successfully utilised for deck and hull renovation as well as equipment repairs such as cracked engine casings. Our deck strengthening technology has been extensively tested for bend, impact, flexural strength, drag and shear adhesion, which provides a durable solution.

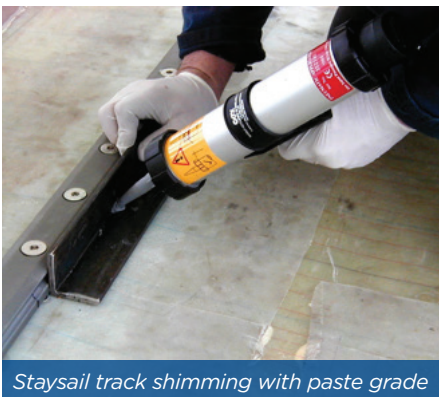
Staysail track shimming with paste grade

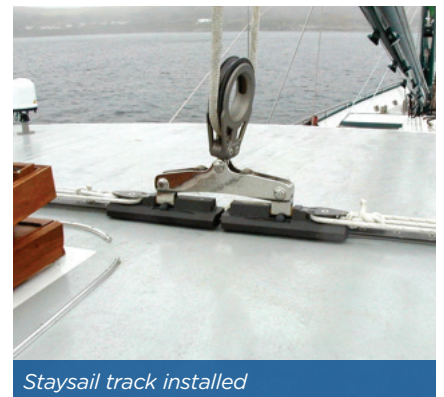
Staysail track installed

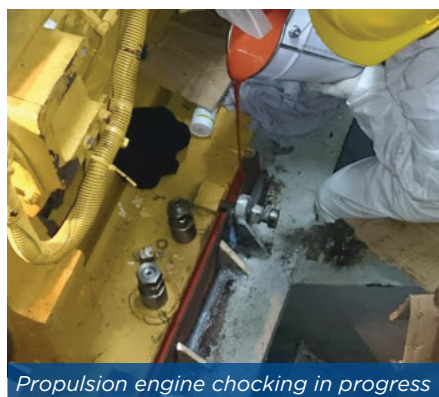
Propulsion engine chocking in progress

Cast compound chocks offer an alternative to conventional metal chocks. Belzona's 100% solids Marine chocking compound has been designed for the installation of Marine engines and other equipment, providing precise equipment alignment due to non-shrinking properties whilst its high impact and compressive strength provides high load bearing capabilities. This self-levelling material is easy to use, shortening installation time and offering a durable non-corroding solution for installation of ship propulsion systems and other heavy equipment where alignment and anchorage is essential.

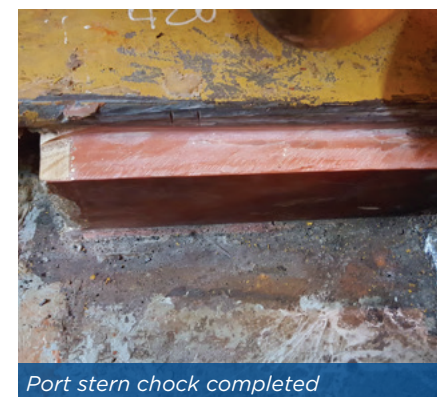
Port stern chock completed

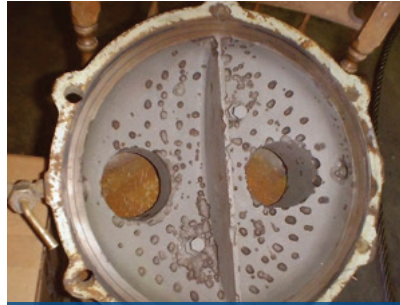
Severe pitting on division bar

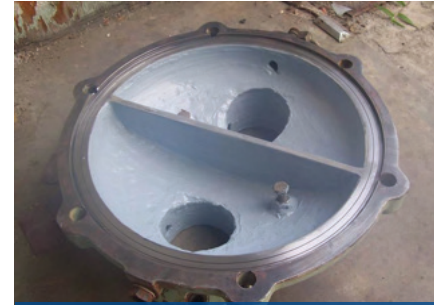
Division bar repaired and protected

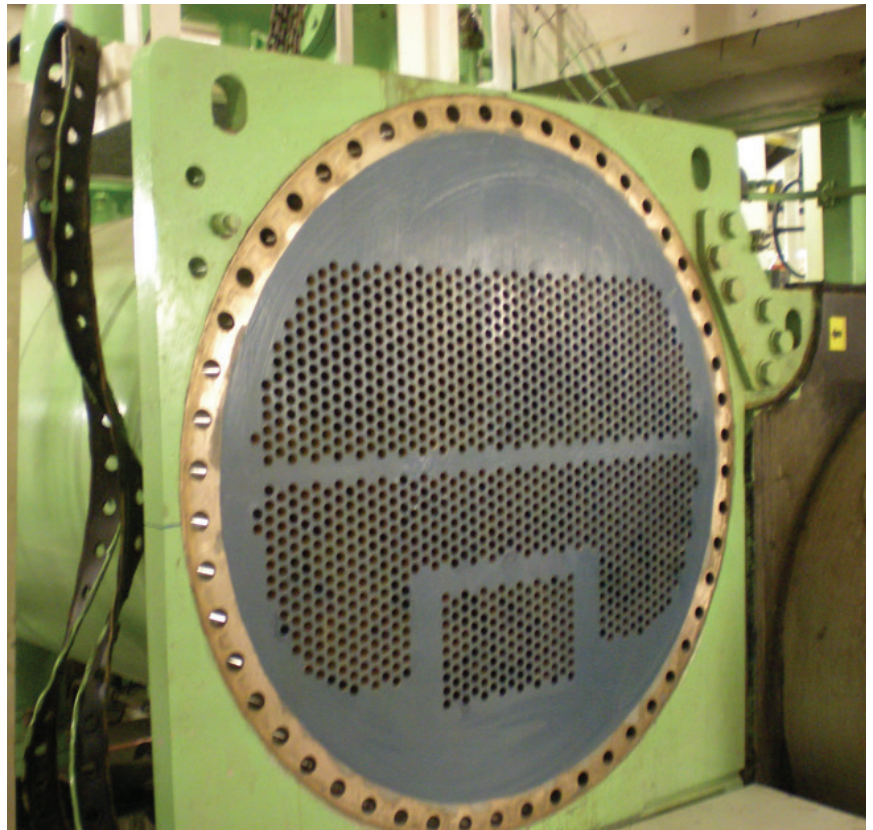
Heat exchanger full refurbishment carried out on board

When exposed to an electrolytic solution, galvanic corrosion occurs at the interface of the tube and the tube sheet. Belzona composites and coatings have been used for heat exchanger repair and protection since the 1970s, with known applications in service for over three decades. The Belzona solution eliminates the need for part replacement, therefore significantly reducing maintenance expenses, and offers excellent adhesion as well as erosion and chemical resistance. In order to prevent galvanic corrosion, new heat exchangers can be designed and coated with Belzona.

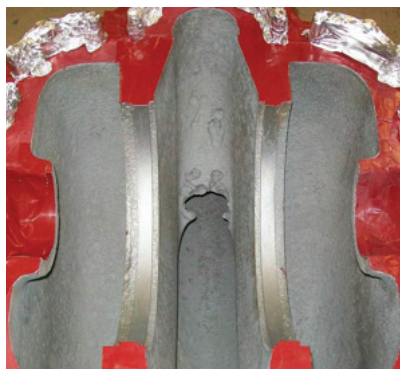
Damaged pump casing

Pump deterioration leads to decreased pumping efficiency and eventually costly part replacement. Pitting, worn wear ring clearances as well as casing damage can be rebuilt using Belzona's composites specifically designed for erosion-corrosion resistance under immersion. Pumping efficiency is restored and enhanced with the use of a hydrophobic smooth lining, which also protects from erosion and corrosion. Once the pump has been protected with Belzona, it can remain maintenance-free for many years with applications still in service decades later.

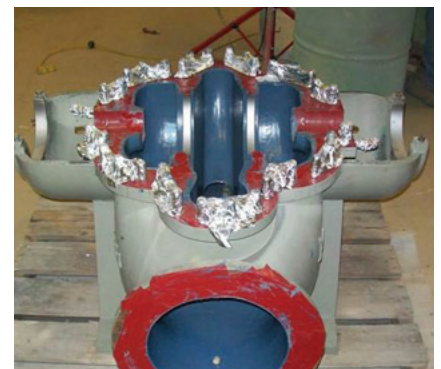
Casing rebuilt and coated

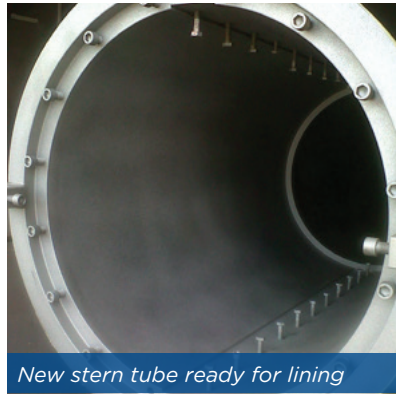
New stern tube ready for lining

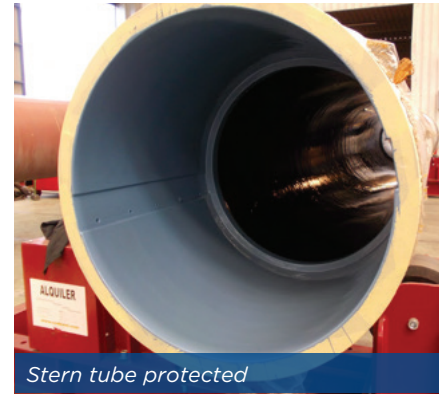
Stern tube protected

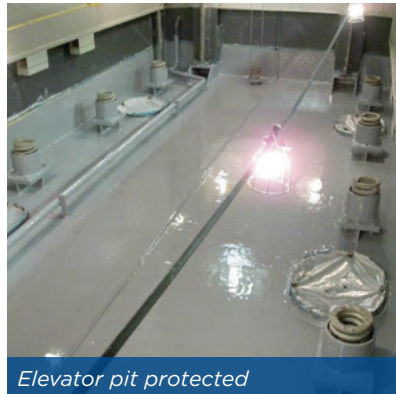
Elevator pit protected

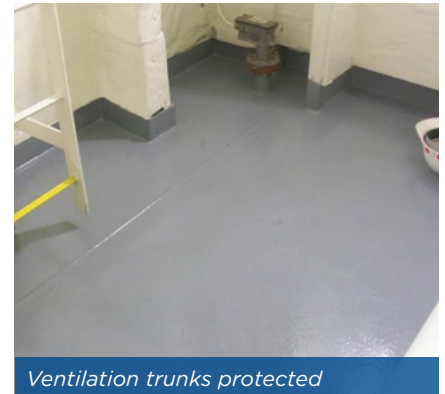
Ventilation trunks protected

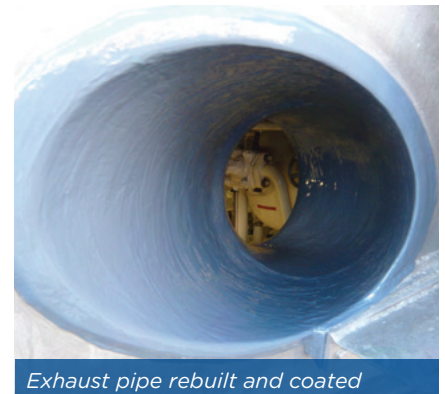
Exhaust pipe rebuilt and coated

Leisure boats with inboard engines often suffer from corrosion problems on the wet exhausts. The hot exhaust gas together with the salt water causes severe corrosion that can lead to critical loss of steel. High temperature resistant composite repair materials are used to recover the metal loss and rebuild the original surface profile of the water inlet and exhaust outlet. A high temperature lining can then be applied to provide long-term protection and eliminate future corrosion issues in the exhaust system.

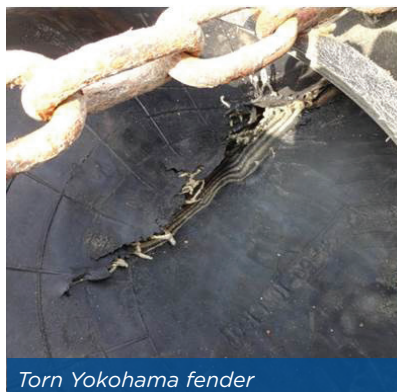
Torn Yokohama fender

By the very nature of their job, mooring equipment such as fenders are subjected to impact, abrasion and wear. As a result, punctures are common and cannot easily be repaired by conventional means such as hot vulcanising, which is time consuming, expensive and not always successful. Belzona Elastomers provide reliable repairs to these common problems. Tears and rips can be repaired using a Belzona Elastomer paste grade material, while surface deterioration is easily resolved with a coating grade.

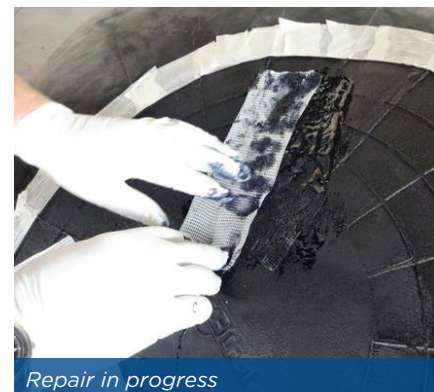
Repair in progress

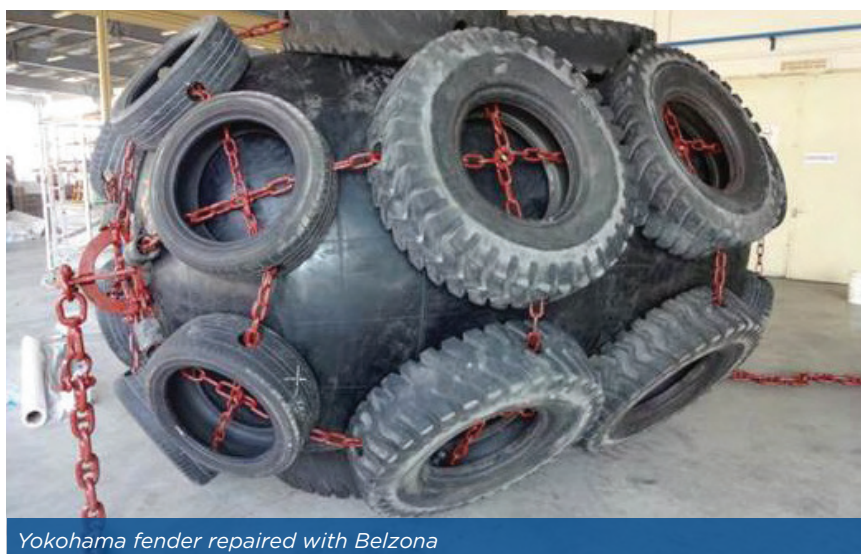
Yokohama fender repaired with Belzona

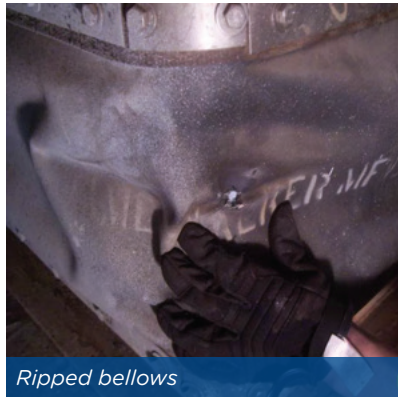
Ripped bellows

Tears or holes on bellows should be immediately repaired to prevent serious mechanical damage; however, ordering and fitting replacements is time consuming and expensive. Belzona Elastomers can provide a fast and reliable repair alternative as these materials bond strongly to rubber and metal. The repair can be performed in-situ with an emergency repair Elastomer, a rubber repair material that cures in minutes.

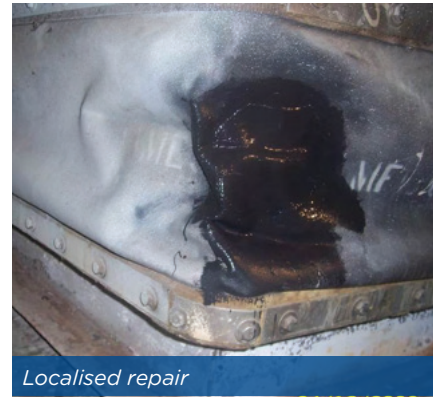
Localised repair

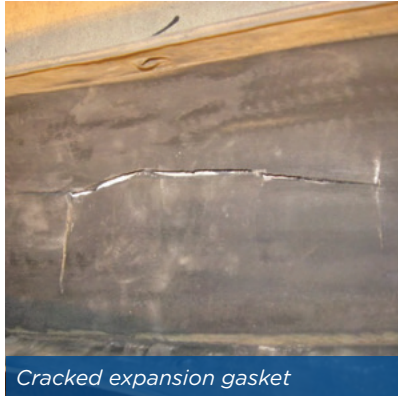
Cracked expansion gasket

Leaking or badly maintained hatch covers are a principal cause of cargo wetting and can lead to more serious consequences such as flooding and accelerated corrosion. Rubber packing that is physically damaged, cut or chafed will cause leaking and need to be rapidly repaired. When replacement seals are not available, liquid applied Belzona Elastomers can be used to rebuild damaged gaskets as they offer excellent durability and flexibility, helping to keep the hatch cover watertight.

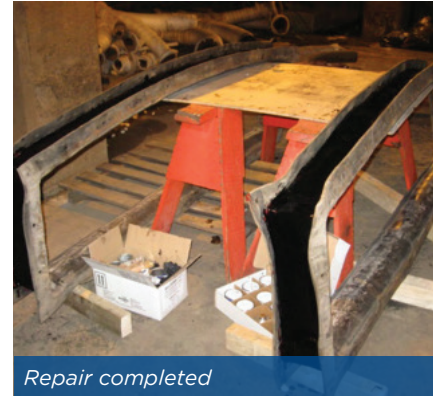
Repair completed

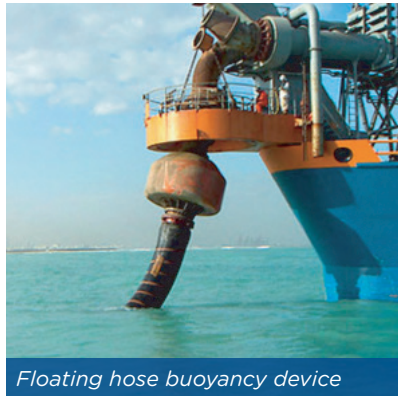
Floating hose buoyancy device

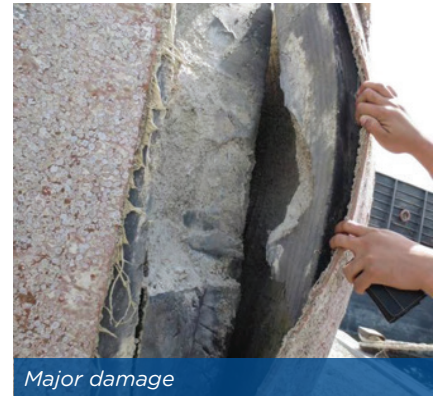
Major damage

Floating hoses and buoyancy devices can represent a significant expense, as the rubber, internal surfaces and flange faces can often be damaged due to in service or in transit deterioration. If the damage is not addressed at an early stage, it can lead to loss of buoyancy and ultimately catastrophic fuel or oil spillage with potentially costly implications.

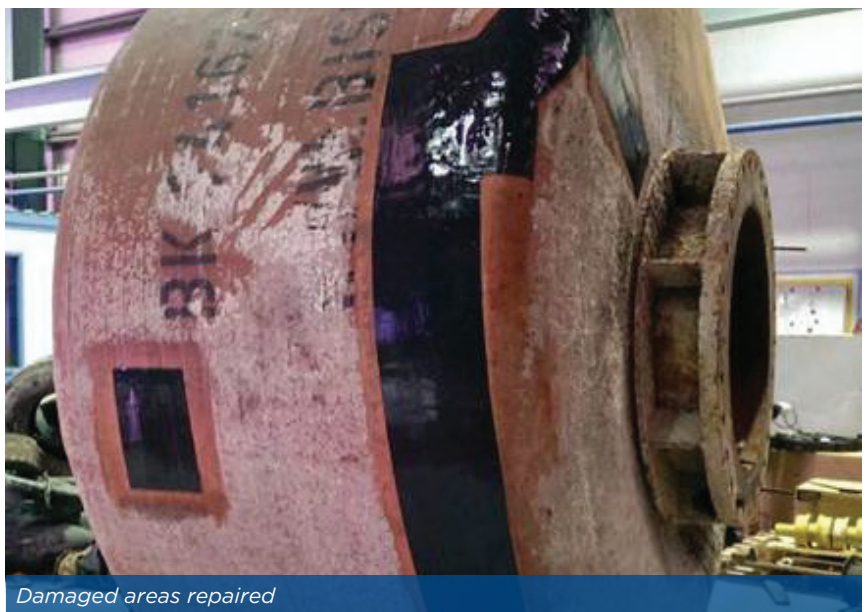
Damaged areas repaired

Belzona Elastomers provide a rapid and resistant repair solution to damaged floating hoses and buoyancy devices. Our rubber repair materials adhere strongly to any type of hose and provide outstanding abrasion and impact resistance once the hose is put back in service. Due to Belzona's range of multi-purpose Elastomers, we are able to repair both localised and large defects, as well as ensure high quality repairs onto vertical surfaces.

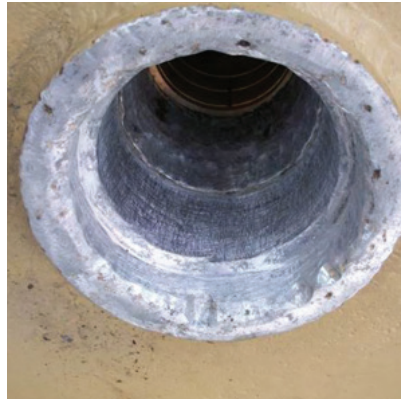
Damaged bearing bushing

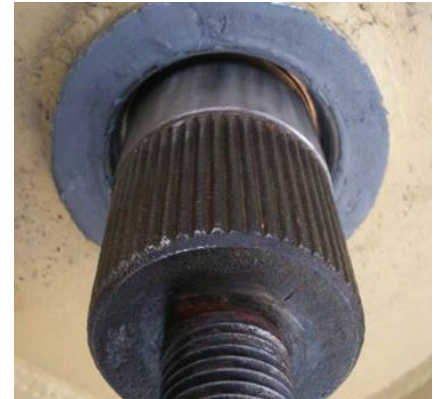
Bearing bushing rebuilt in situ

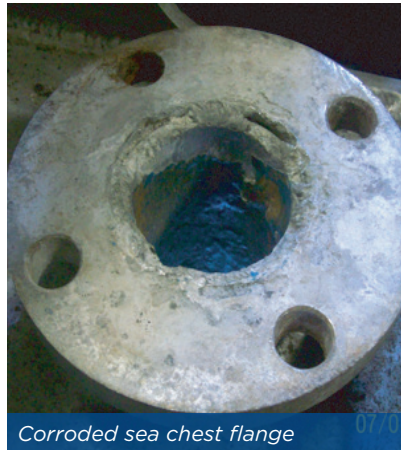
Corroded sea chest flange

Crevice and galvanic corrosion can be repaired with a unique Belzona composite forming technology. Prefabricated formers are used to shape the specified Belzona material, which bonds strongly to the flange face. The sealing face is then effectively isolated from corrosive media whilst maintaining its shape and profile. This simple repair can be carried out in situ without disassembling the equipment and eliminating the need for welding.

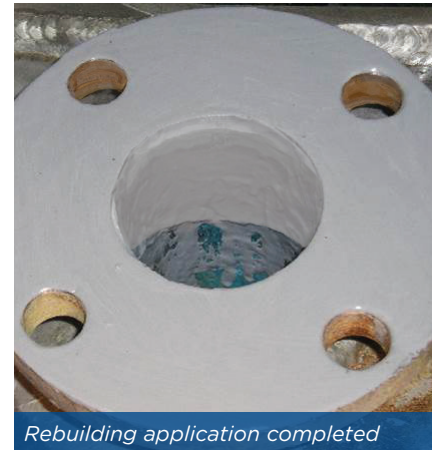
Rebuilding application completed
