# MAINTAINING ASSET INTEGRITY IN THE OIL AND GAS INDUSTRY – UPSTREAM

Belzona Protective Coatings and Engineering Composites

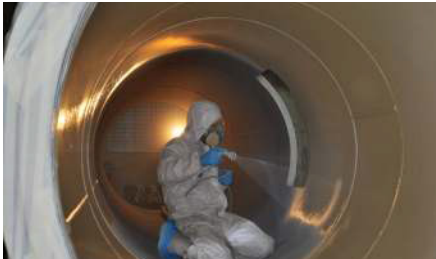
100% solids epoxy protective linings for erosion-corrosion protection

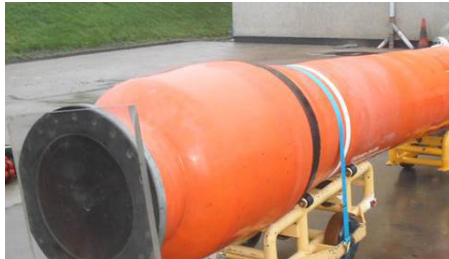
High performance polyurethanes for flexible repairs

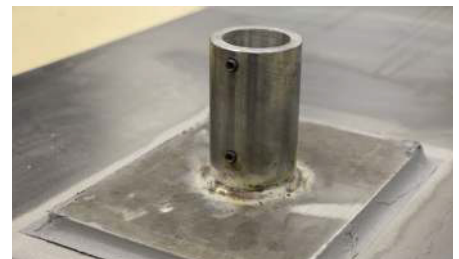
Composites for bonding, forming, shimming and rebuilding

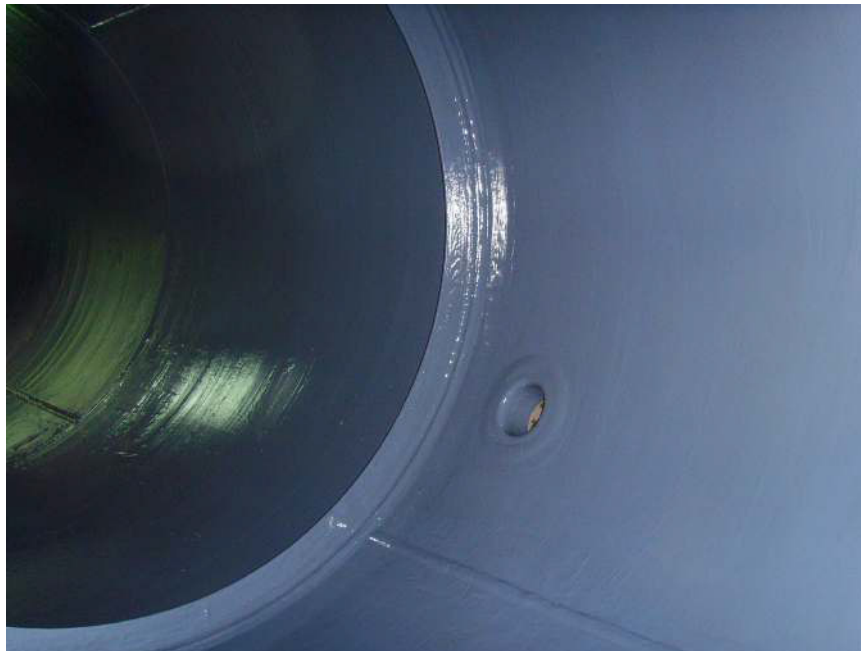
*Belzona lining applied to a newly fabricated separator*

Belzona liquid applied vessel linings were first specified in 1987 for separator corrosion repair and protection at a UK North Sea platform. Outstanding erosion resistance prevented wear during the sand jetting system operation and has prompted the use of Belzona linings on hundreds of other vessels. We now offer a complete solution for pressure vessels handling liquid hydrocarbons, gas and process chemicals including separators, slug catchers, knock-out drums and many more. Based on the experience of corrosion repair and prevention, spanning two decades, in the early 2000s asset owners and operators began to specify Belzona linings at the design stage to protect newbuild vessels.

Our linings can be spray or hand applied and, once cured in service, form a barrier between the substrate and corrosive media, enabling the operator to implement a corrosion management plan. As well as resisting erosion-corrosion, Belzona linings are designed to withstand vast pressure and temperature fluctuations, including steam-out and explosive decompression.

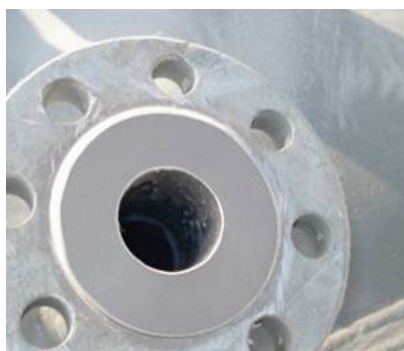
*Cold forming isolates flange faces from corrosive media*

Crevice and galvanic corrosion can be prevented or repaired with a unique Belzona composite forming technology. Prefabricated formers are used to shape the specified Belzona material that bonds strongly to the flange face. The sealing face is then effectively isolated from corrosive media whilst maintaining its shape and profile.

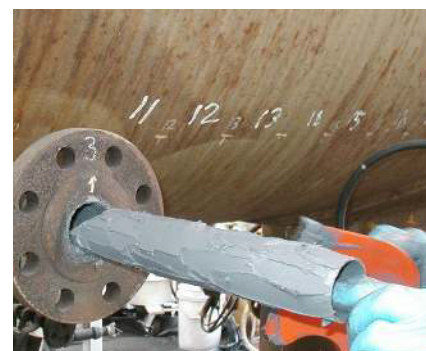
*Prefabricated Belzona insert bonded into small bore nozzle*

Narrow nozzles no longer need to be considered "the Achilles' heel" of process vessels. Tailor made Belzona inserts can be bonded into the nozzle using a fluid grade material, eliminating the risk of pinholes or holidays. Excellent chemical and erosion resistance ensures long-term protection of the nozzle, thus extending maintenance-free periods.

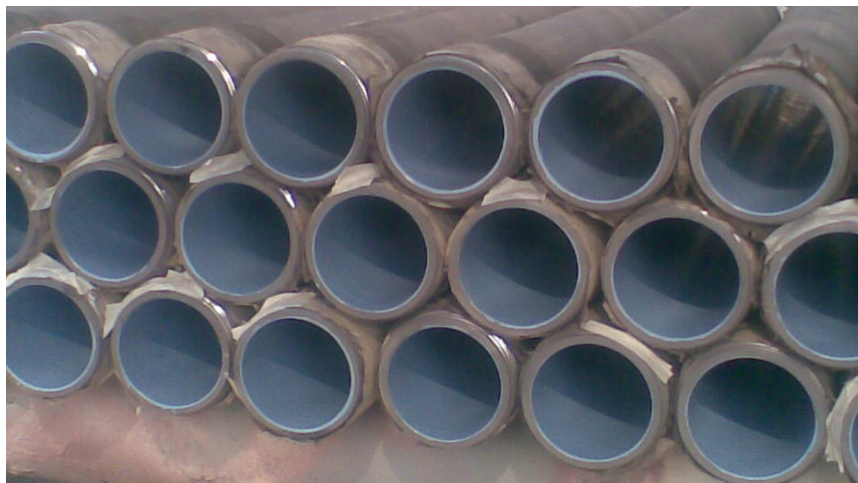
*Internal pipe lining*

Sand entrainment and high flow rates coupled with large quantities of CO<sub>2</sub>, H<sub>2</sub>S and brine can lead to pipe corrosion rates of several hundred mils per year. In 2012, Belzona pioneered a spray-friendly pipe lining system that offers erosion-corrosion protection. The substitution of hard-ceramic fillers for a thermoplastic filler blend ensures there is very little wear to the spray equipment.

Sprayable erosion-corrosion protective linings allow for the material to be spin spray applied in situ at wet film thickness up to 1250 microns without sagging, effectively covering girth welds and joints in a single coat. The thermoplastic filler blend is formulated to achieve excellent impact and sliding abrasion resistance, a high degree of toughness and chemical resistance.

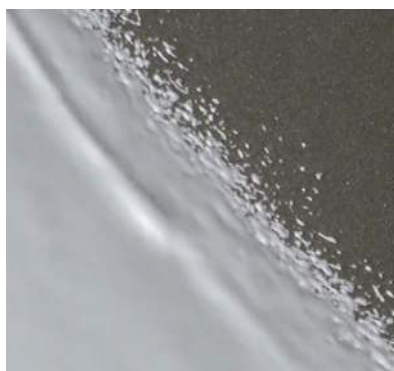
*Girth weld covered in a single coat*

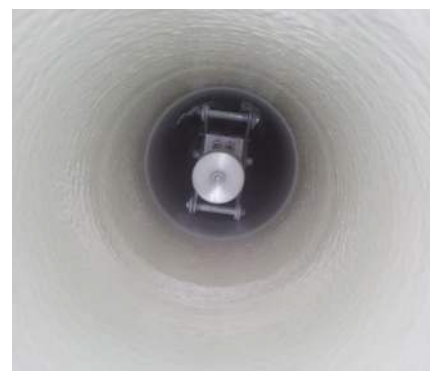
*Spin spray application*

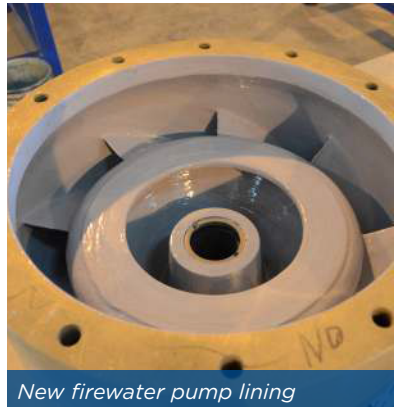
New firewater pump lining

Due to over 30 years' experience in repairing and restoring upstream pumps, Belzona linings are now specified to protect new pumps, thus significantly extending the lifetime of the assets and subsequent maintenance-free periods. Belzona linings have become a first choice in protecting firewater pumps in particular, offering long-term corrosion protection and seizure prevention.

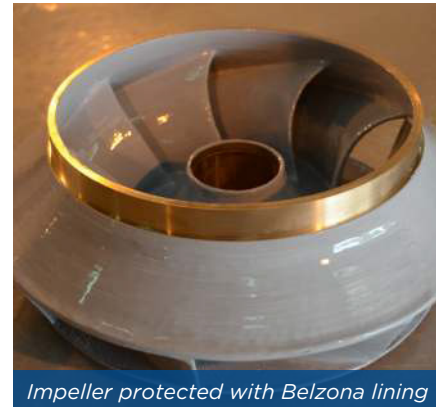
Impeller protected with Belzona lining

Pump deterioration leads to decreased pumping efficiency and eventually costly part replacement. Pitting, worn wear ring clearances as well as casing thin and through wall defects can be rebuilt using composites specifically designed for pumping applications. Pumping efficiency is restored and enhanced with the use of a hydrophobic smooth lining, which also protects from erosion-corrosion and cavitation. Once the pump has been protected with Belzona, it can remain maintenance-free for many years.

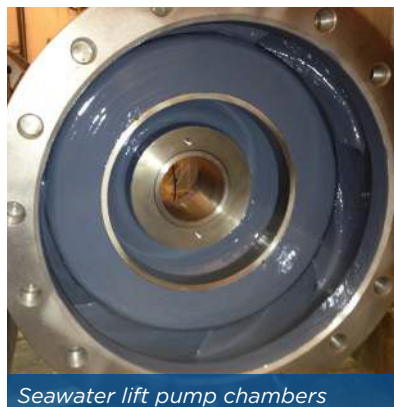
Seawater lift pump chambers

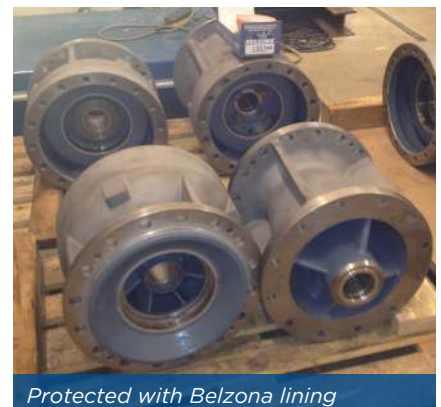
Protected with Belzona lining

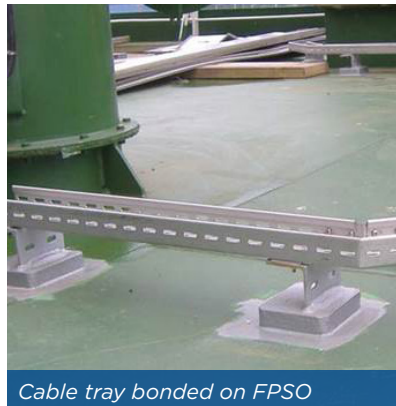
Cable tray bonded on FPSO

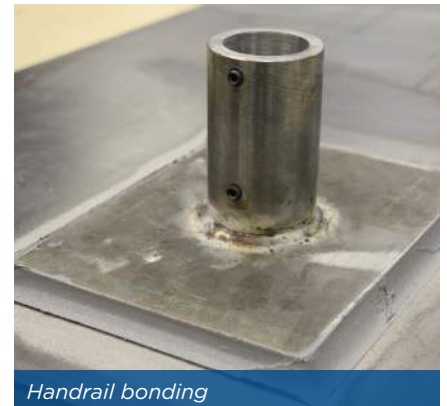
Handrail bonding

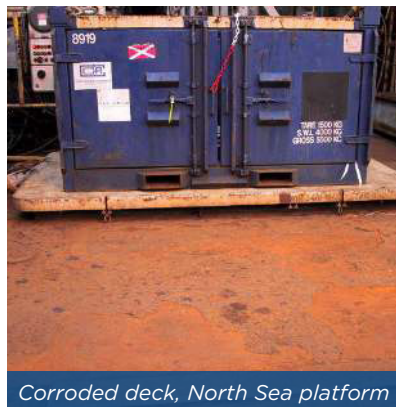
Corroded deck, North Sea platform

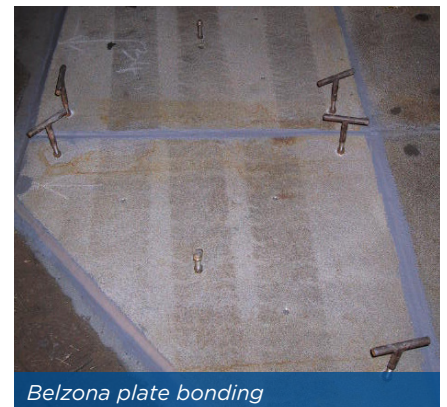
Belzona plate bonding

Corroded equipment and structures can be repaired in situ with Belzona's pioneering injection bonding technology. This technique has been successfully utilised for deck renovation and other structural integrity repairs. Over a decade of successful applications, which are still in service today, attest to this method's effectiveness and have prompted engineering houses to specify injection bonding for greenfield applications.

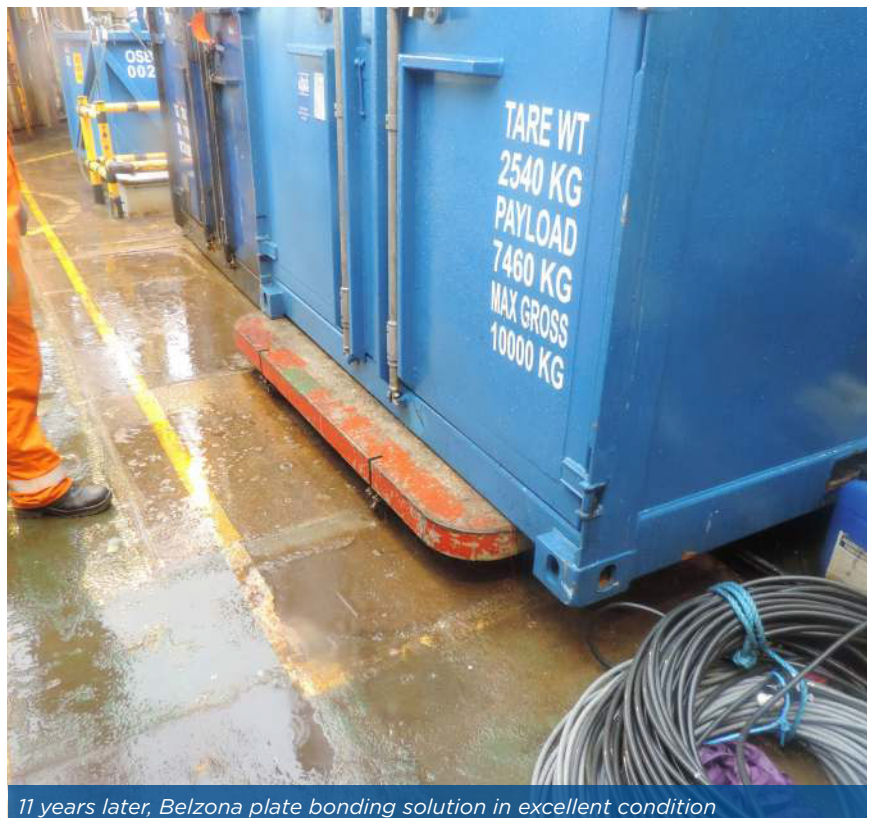
11 years later, Belzona plate bonding solution in excellent condition

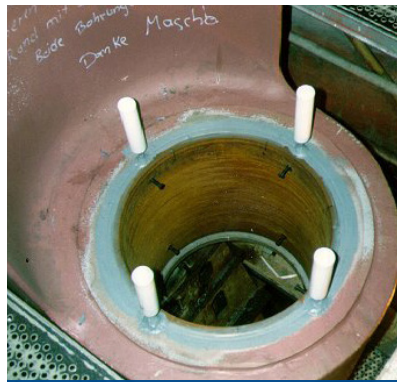
Rudder bearing bonding - top view

Bearing bonding is carried out by injecting the Belzona material between the bearing and the housing. The Belzona shim takes up any ovality or housing wear, thus creating a durable barrier with 100% surface contact, electrically isolating the bearing. This method has been applied to multiple situations including riser bearings and bushes amongst others.

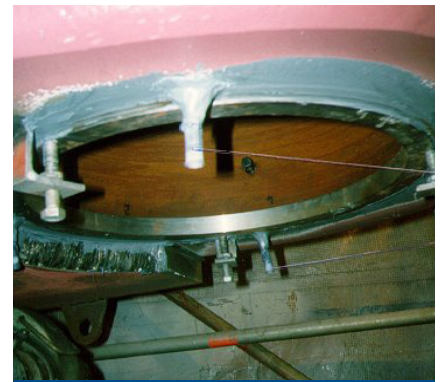
Rudder bearing bonding - bottom view

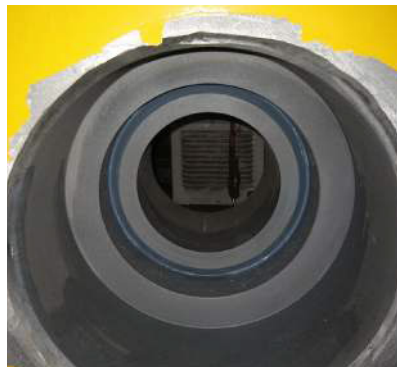
Bush installation, North Sea

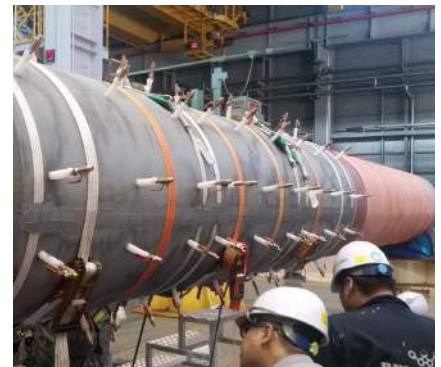
Riser bearing bonding

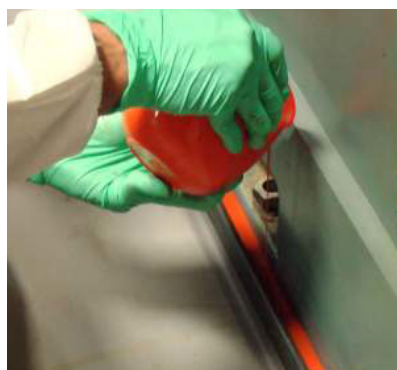
Pourable shimming in action

Following over five decades of bonding and shimming applications, in 2014 Belzona developed a novel pourable chocking compound. The system is ideal for pouring foundations for heavy equipment and to maintain precise alignment under machinery ensuring effective bearing underneath.

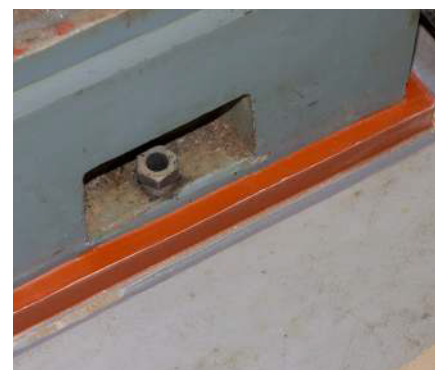
Bespoke chocking solution

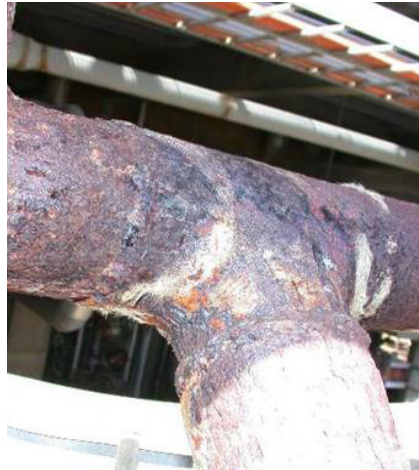
Corrosion under insulation

Corrosion under insulation occurs at an accelerated rate and can remain undetected for some time. Taking affected parts of the pipework out of service for repairs or replacement can in turn lead to high costs and lengthy downtime. To address this problem, in the late 1990s, Belzona formulated heat activated composites and coatings that facilitate on-line repairs. These materials adhere exceptionally well to hot contaminated surfaces and penetrate deep into the substrate eliminating the need for an angular blast profile prior to application.

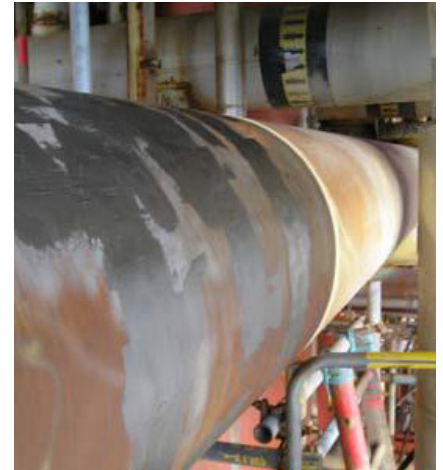
Pit filling

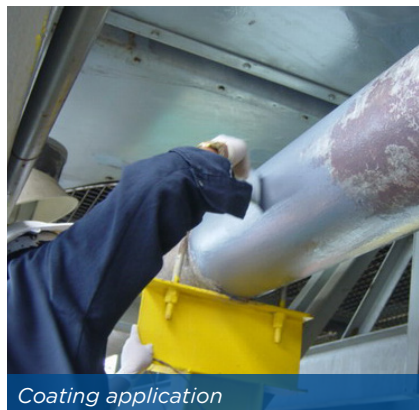
Coating application

Simple manual surface preparation and on-line brush application have inspired the use of Belzona heat activated materials to combat CUI globally, from the Gulf of Mexico to the North Sea. Typical applications in the range of -10°C to 150°C (50°F - 302°F) will resist salt spray and commonly found inorganic acids and alkalis at concentrations up to 20%.

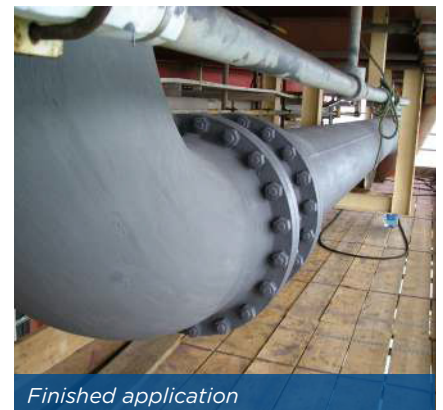
Finished application

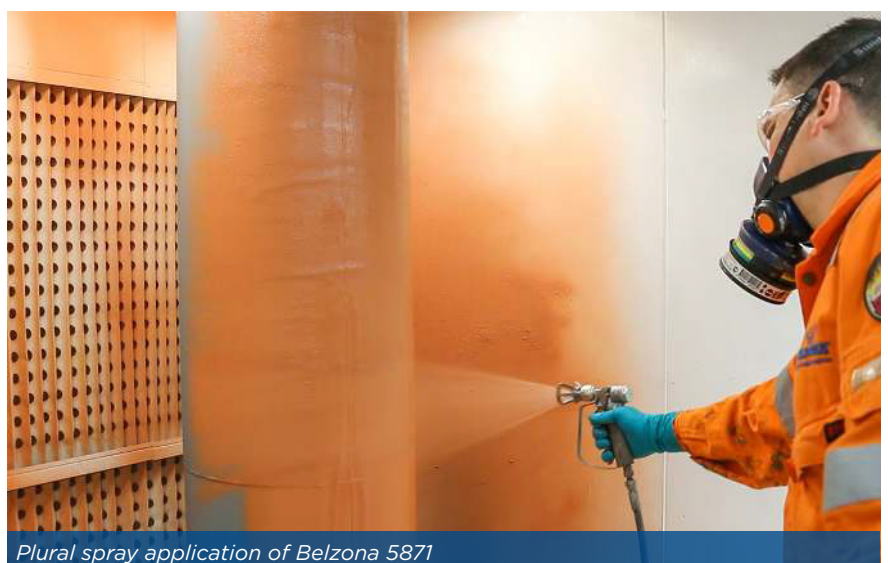
Plural spray application of Belzona 5871

Belzona have developed a solution that provides thermal insulation to metal pipework, ductings and other industrial equipment whilst also displaying excellent corrosion resistance and eliminating corrosion under insulation (CUI).

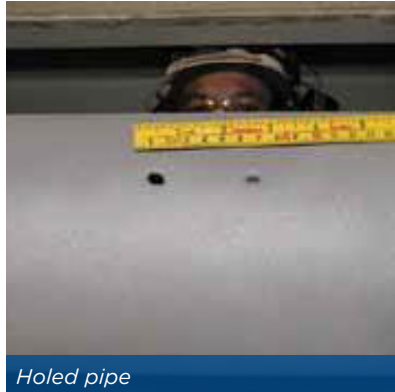
*Holed pipe*

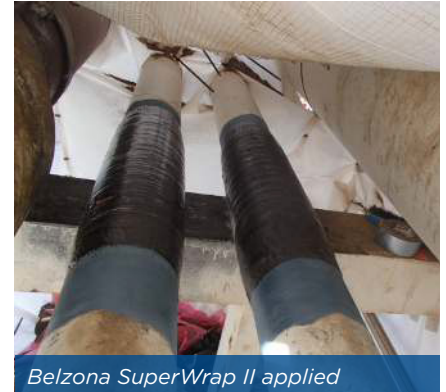
*Belzona SuperWrap II applied*

Following almost five decades of pipe wrap installations, in 2007 we added Belzona SuperWrap to the range, which is compliant with ASME PCC2 Article 4.1 and ISO/TS 24817. Every Belzona SuperWrap system is individually designed and applied by validated specialists. Repairs can be carried out to a variety of defects to restore pressurised pipeline and pipework integrity. In 2014, Belzona SuperWrap II was released, which exhibits greater strength and allows for a much more efficient application procedure, therefore reducing overall costs and downtime.

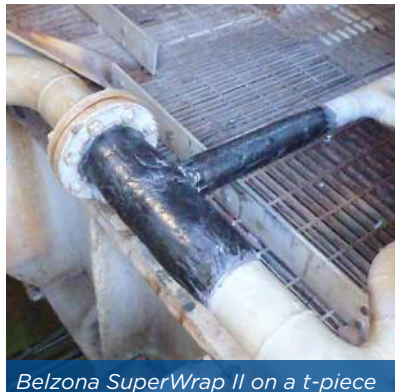
*Belzona SuperWrap II on a t-piece*

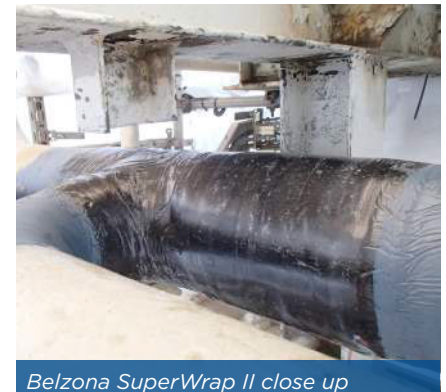
*Belzona SuperWrap II close up*

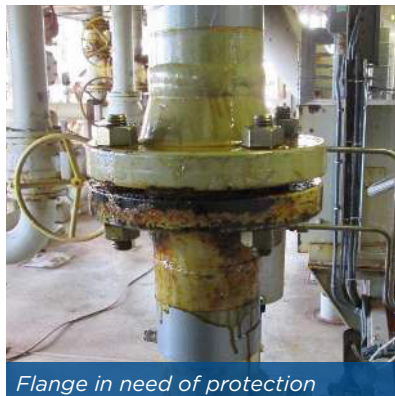
*Flange in need of protection*

Repairing flange crevice corrosion can be a very costly exercise, whereas common preventative measures in most cases are not 'inspection friendly'. The Belzona encapsulating membrane system introduced in 2014 seals bolted flange connections preventing corrosion. The liquid applied system includes a corrosion inhibitor and was designed to allow for periodic inspection, where flexible protection can be cut, peeled back and then easily resealed. To maintain Health and Safety standards, the system is hand applied, cures at ambient temperatures and can resist common corrosive media.

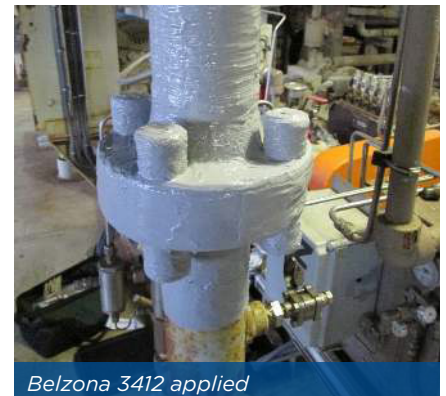
*Belzona 3412 applied*

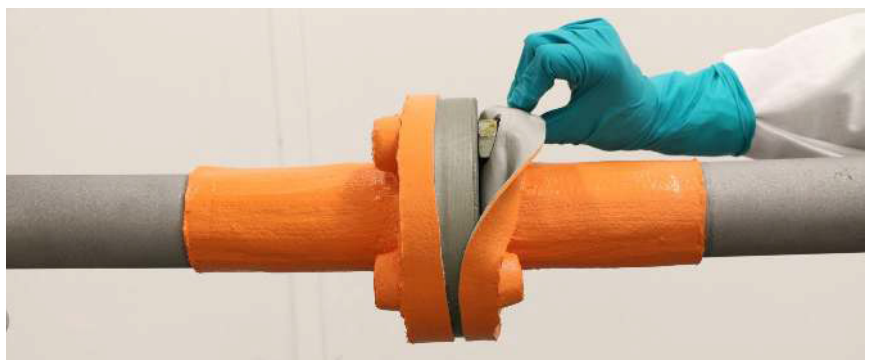
*Peel to inspect, reseal to protect*

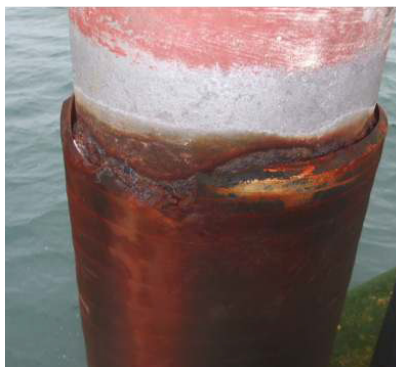
*Corroded riser*

Rubber cladding does not offer permanent protection and tends to deteriorate after a few years in service, with sea water corroding the steel underneath the cladding. Belzona offers a complete system, which restores corroded metal and repairs cladding in situ, sealing the neoprene boot topping of the riser, thus preventing further water permeation. Due to proven longevity of cladding edge sealing, marine engineers specify Belzona flexible solution on new risers to prevent water ingress between the cladding and the metal.

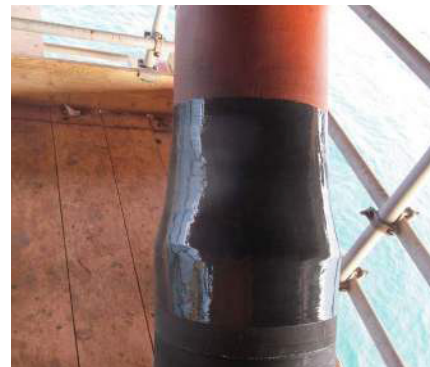
*Corrosion repaired and cladding sealed*

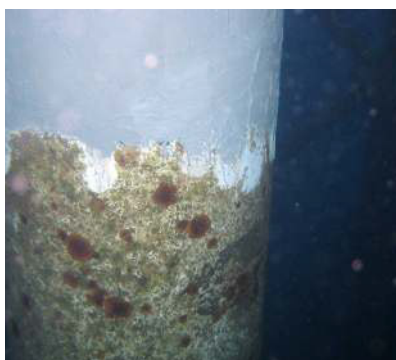
*Corroded platform leg*

Sea water movement with abrasive residues is capable of wearing away sacrificial protection and causing severe damage to the platform legs, particularly around the water line. Belzona surface-tolerant materials can be used to rapidly repair and prevent platform leg corrosion. Liquid-applied in situ and long lasting, the system forms a durable barrier between the substrate and the sea water.

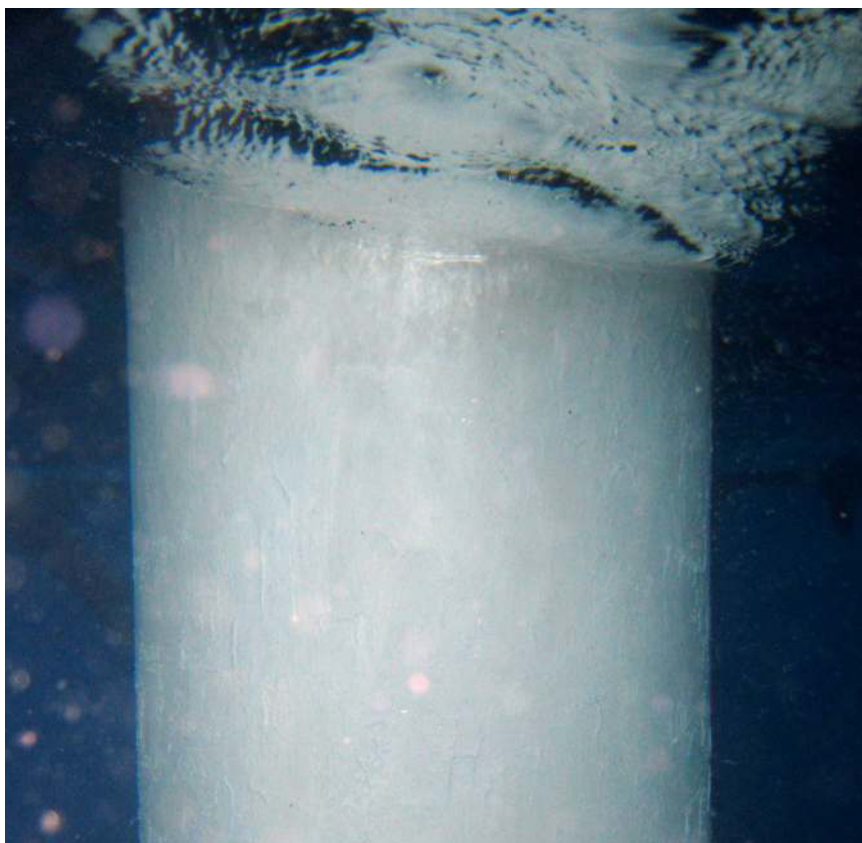
*Inspected five years later*

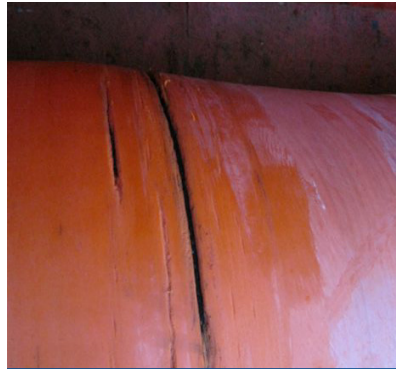
*Hose damaged in transport*

Hoses can be damaged in service or in transit and require a fast and durable repair solution. Belzona Elastomers adhere strongly to any type of hose and provide outstanding abrasion and impact resistance once the hose is put back in service. Belzona Elastomers are endorsed by reputable floating hose manufacturers as their recommended repair material. Corroded flange faces and internal surfaces can also be repaired and protected with the use of Belzona lining and flange face forming technology.

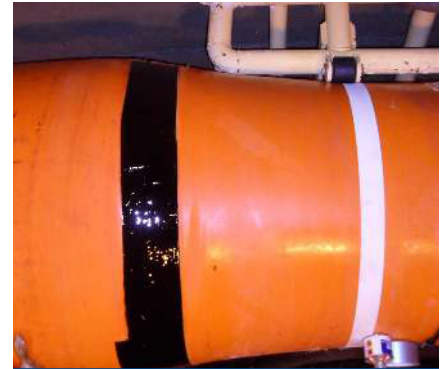
*Belzona flexible repair*

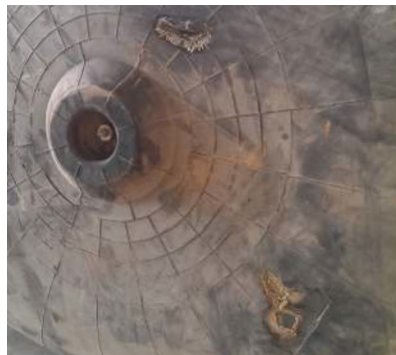
*Deteriorated fender*

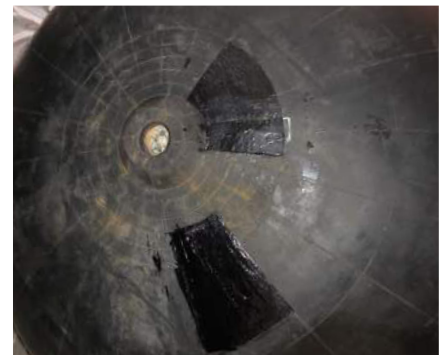
*Fender repaired*

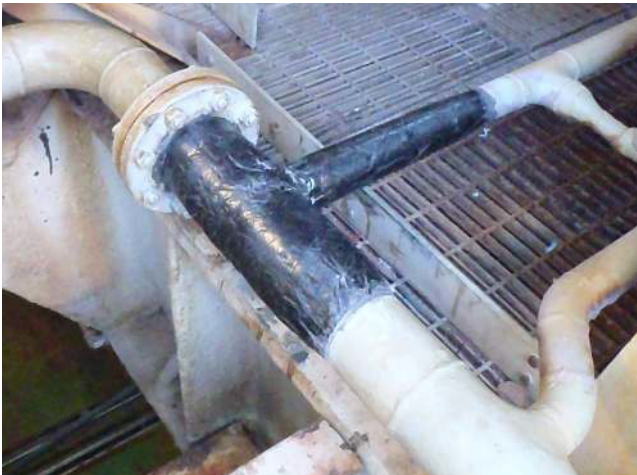
**HEAT ACTIVATED COATINGS**  
for hot surface repairs on-line

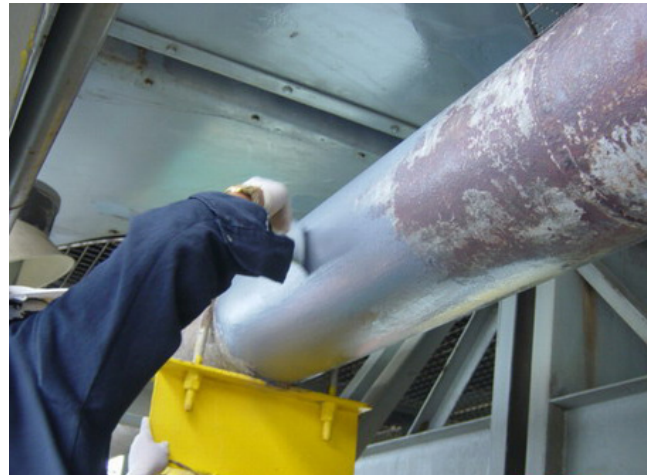
**SURFACE-TOLERANT PROTECTION**  
for applications above and below the waterline
