MAINTAINING ASSET INTEGRITY IN THE POWER INDUSTRY

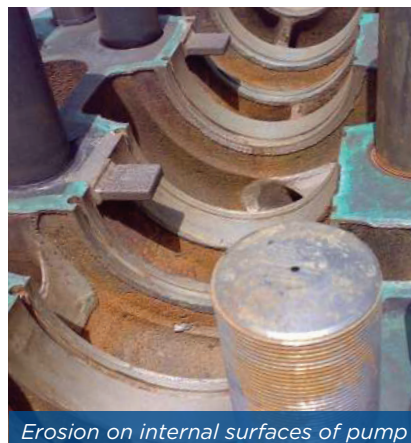
Erosion on internal surfaces of pump

Pump deterioration can lead to decreased pumping efficiency, higher energy consumption and eventual costly part replacement. Pitting, worn wear ring clearances as well as thin-wall and through-wall casing defects can be rebuilt using cold-applied paste grade composites which provide long-term corrosion and erosion resistance.

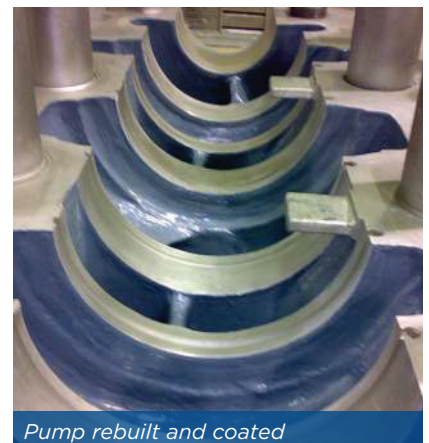
Pump rebuilt and coated

After the surface profile has been rebuilt, the pump internal areas can be protected for the long term against the effects of erosion-corrosion with a Belzona 1300 Series coating. Pumping efficiency can be restored and enhanced with the use of a hydrophobic smooth lining. Belzona 1341 (Supermetalglide) has demonstrated efficiency increases of up to 7% on new equipment and up to 20% on refurbished assets.

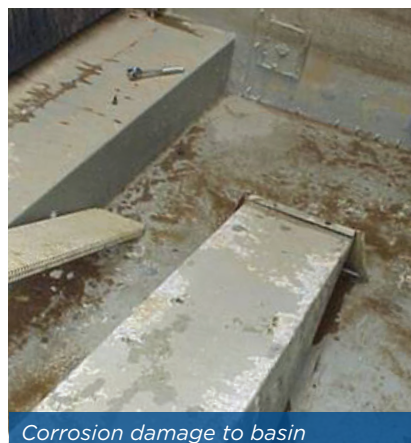
Corrosion damage to basin

Commonly, cooling tower basins are constructed from steel or concrete and, over time, suffer from general corrosion. The water treatment chemicals used to prevent scale and fouling further accelerate corrosion rates. Corrosion of the hot well and sump at the base of the tower is a common problem which can be prevented with Belzona.

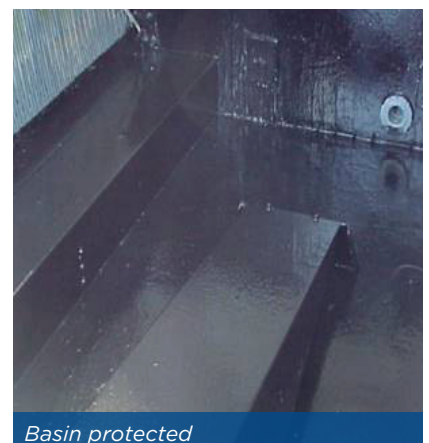
Basin protected

Belzona 5800 Series coatings are specifically designed to be suitable for continuous immersion in aqueous solutions such as cooling water. These materials will also continue to provide protection even if the water chemistry is seriously compromised.

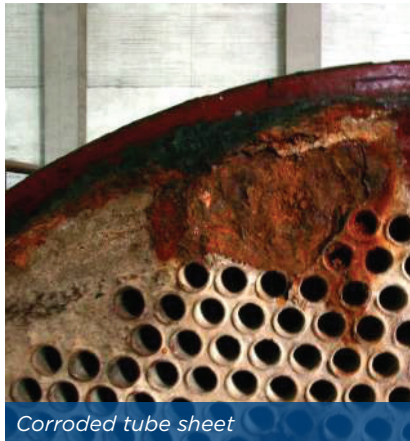
Corroded tube sheet

When exposed to an electrolytic solution, galvanic corrosion can occur at the interface of the tube and the tube sheet. Belzona materials halt galvanic corrosion, preventing continuing metal loss, and offer excellent erosion and chemical resistance. This eliminates the need for part replacement and significantly reduces maintenance expenses. A Belzona 1100 Series rebuilding metal can be used to rapidly repair and rebuild damaged tube sheets in situ, prior to the application of a long-lasting protective coating.

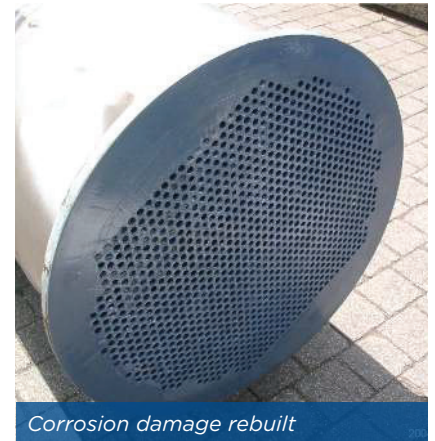
Corrosion damage rebuilt

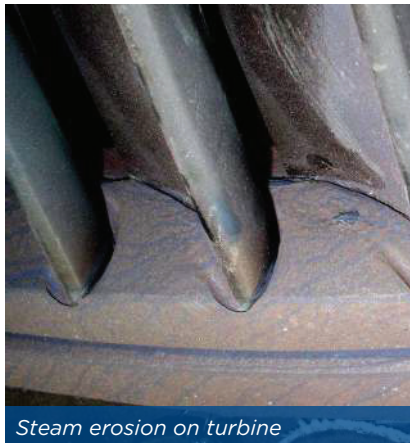
Steam erosion on turbine

Despite their importance, steam turbines are often condemned due to operating inefficiency or rising vibration levels. In cases where evidence of steam erosion-corrosion is visible, a Belzona solution can be utilised to provide a long-term repair. Turbine diaphragms, flanged joints and rotors can be repaired and protected using Belzona 1100 Series rebuilding composites and Belzona 1300 Series coatings. Our solutions offer exceptional continual wear resistance whilst demonstrating excellent erosion-corrosion protection. By utilising a Belzona solution, steam turbine operators can expect significant cost savings when compared to equipment replacement.

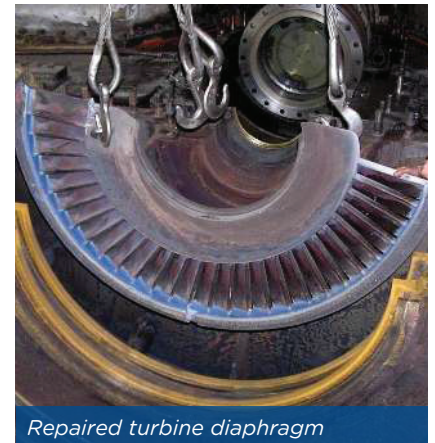
Repaired turbine diaphragm

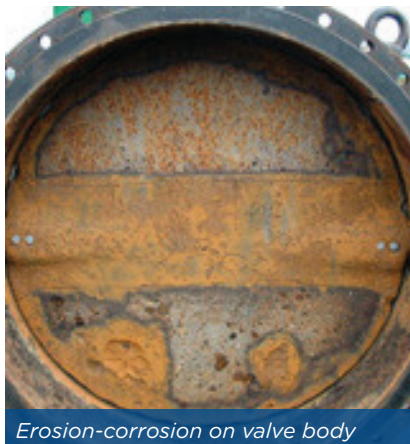
Erosion-corrosion on valve body

Common causes of damage and deterioration to pipes, valves and fittings can include impact and frost damage, corrosion, erosion and chemical attack. Belzona provides a wide range of cold-curing repair composites and epoxy-based immersion coatings specifically designed to offer outstanding erosion and corrosion protection coupled with excellent chemical resistance.

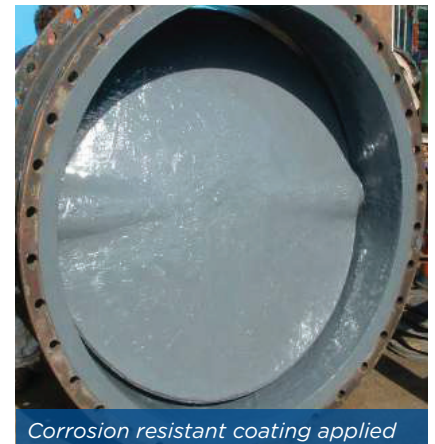
Corrosion resistant coating applied

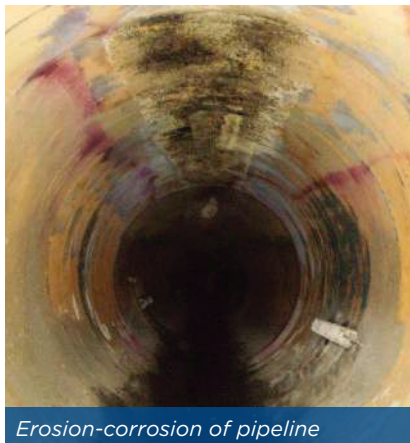
Erosion-corrosion of pipeline

Belzona pioneered a spray-friendly pipe lining system that offers outstanding erosion-corrosion protection. The substitution of hard ceramic fillers for a thermoplastic filler blend ensures there is very little wear spray equipment. These linings allow for in-situ spin spray applications at wet film thickness over 1,200 microns without sagging, effectively covering girth welds and joints in a single coat.

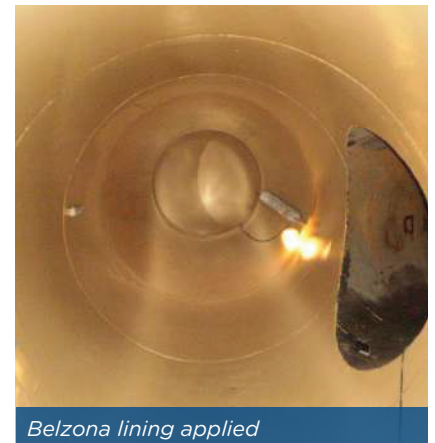
Belzona lining applied

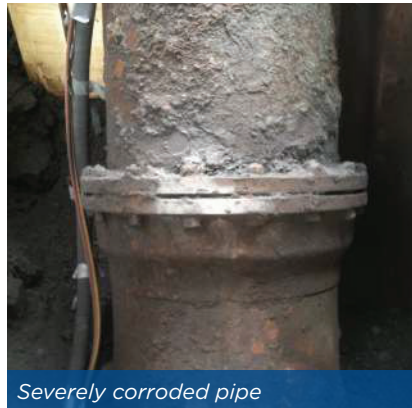
Severely corroded pipe

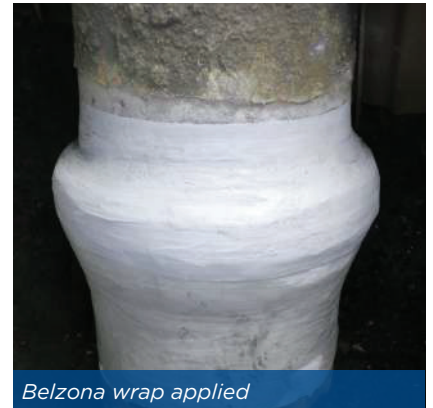
Belzona wrap applied

A wrap system is composed of a reinforcement sheet and a Belzona composite material, tailored to the asset's performance criteria, such as presence of contaminants, operating temperature and pressure levels amongst others. Following almost five decades of pipe wrap applications, Belzona SuperWrap II was introduced to repair corroded, weakened and holed pipe and tank walls. This system is compliant to ASME PCC2 Article 4.1 and ISO/TS 24817.

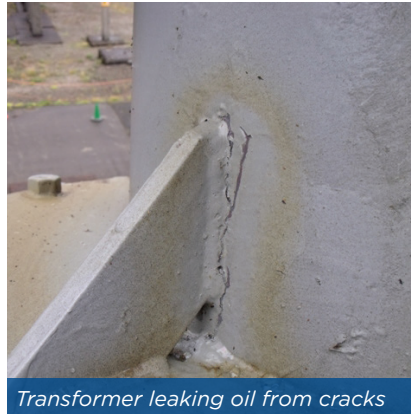
Transformer leaking oil from cracks

Transformer leaks are commonly caused by degrading gaskets or holing as a result of corrosion and impact in the radiator fins or steel tanks. Often these leaks present as slow drips but, over time, large volumes of oil can be lost, spilling hundreds of gallons of mineral oil into the environment. If a failure like this occurs it can cause the transformer to short circuit and result in health and safety concerns. These dangers, coupled with the transformers' isolated locations, make inspection, repair and maintenance a major challenge.

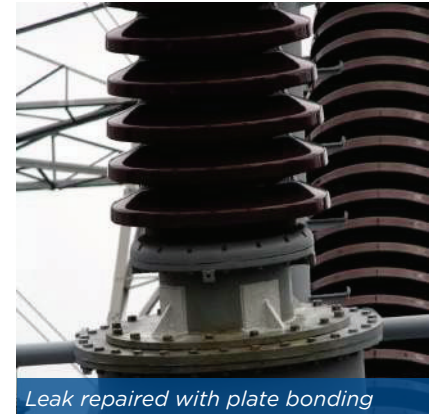
Leak repaired with plate bonding

By utilising a Belzona 1200 Series emergency rebuilding paste grade material, repairs can be undertaken quickly and in situ without the need to drain the transformer oil.

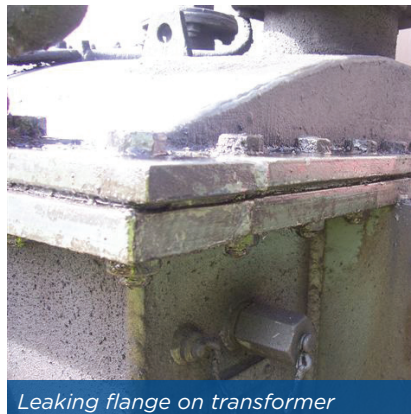
Leaking flange on transformer

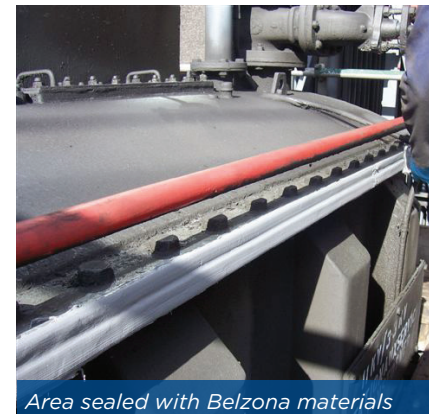
Area sealed with Belzona materials

Surface-tolerant, fast-curing materials such as Belzona 1212 will bond strongly to oily and wet metal surfaces. These cold-applied materials eliminate the need for hot work and have been designed to be easy and safe to use.

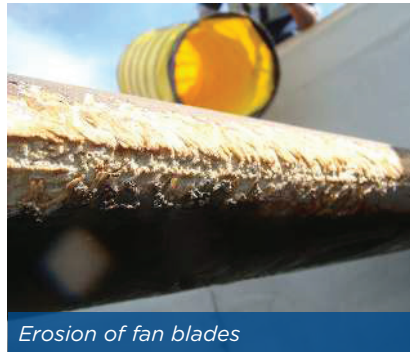
Erosion of fan blades

Cooling tower fan blades commonly suffer from erosion, corrosion, impingement and UV degradation. On leading edges this can reduce the overall efficiency and operation of the cooling system, raising concerns over blade replacement.

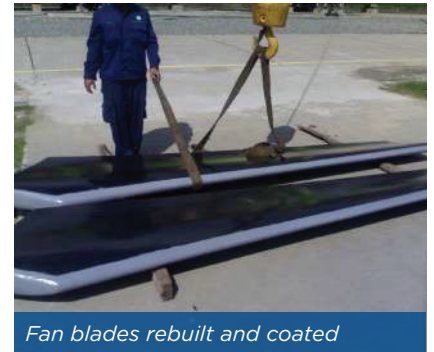
Fan blades rebuilt and coated

Belzona erosion and corrosion resistant paste grade materials and coatings are extensively used by power plant engineers to repair, protect and even increase the efficiency of damaged fan blades. After rebuilding the leading edge profile with a paste grade material for pit filling or by cold bonding a steel plate where the damage is more extended, a Belzona 1300 Series erosion resistant coating is applied to provide long-term protection. A Belzona 5000 Series coating can be used on the blade body to protect it against corrosion and environmental degradation.

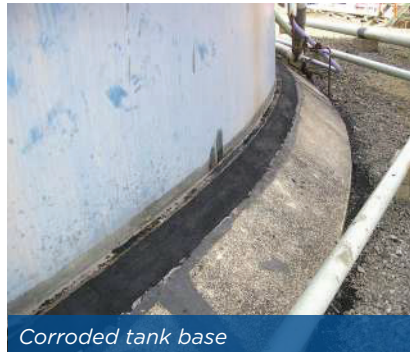
Corroded tank base

Sealant failure, adverse weather conditions or condensation can lead to corrosion of the tank base, leakage and ultimately tank failure. To combat these problems, Belzona formulated a tank base sealing system in the mid 1960s, which is liquid applied in conjunction with a reinforcement sheet. As a membrane, the system possesses a unique breathable feature; liquid cannot permeate the membrane. However, the vapour escapes freely, allowing for the base seal to stay dry. The system remains flexible in service and adapts to thermal expansion loading, while at the same time offering excellent UV resistance.

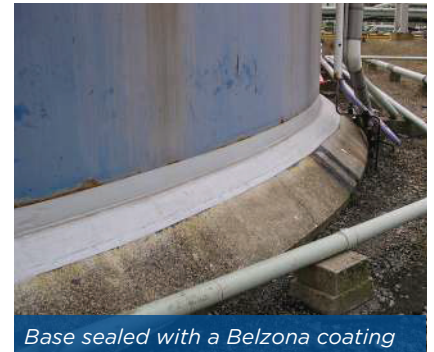
Base sealed with a Belzona coating

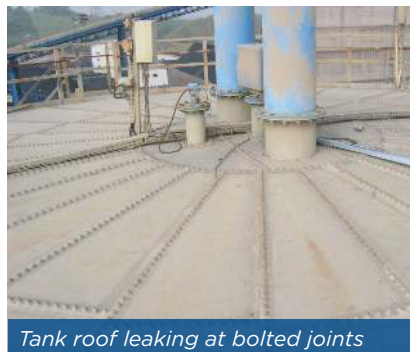
Tank roof leaking at bolted joints

Tank roofs are susceptible to rapid deterioration caused by the corrosive vapour of the storage media and is exacerbated by external forces. Roof damage can be safely repaired in situ and on-line, eliminating the need to degas and drain the tank.

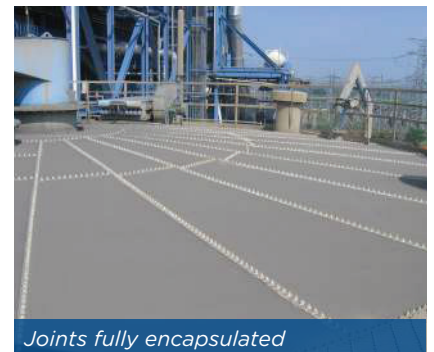
Joints fully encapsulated

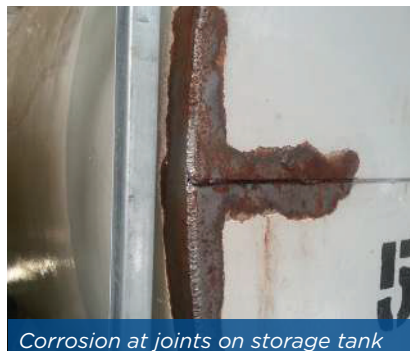
Corrosion at joints on storage tank

Tank walls can also suffer from corrosion and leaking welds. Belzona repairs can be carried out on-line with the use of cold bonded doubler plates or a reinforced composite system. The cold bonding technique can be utilised, not only for repairs, but also for bonding rails, pipe supports and other fittings.

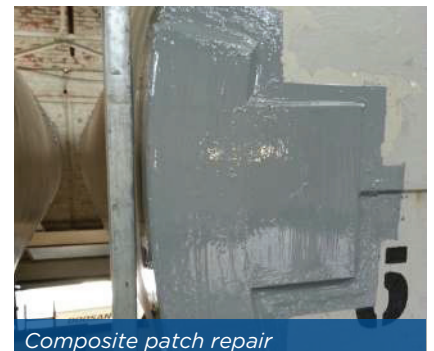
Composite patch repair

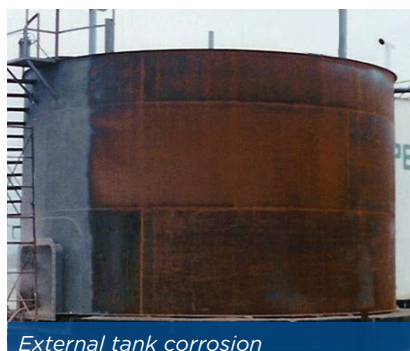
External tank corrosion

Spray applied, corrosion resistant epoxy coatings provide easy to clean surfaces and long-term corrosion protection for tank external surfaces.

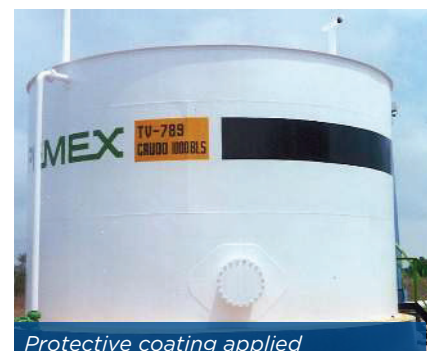
Protective coating applied

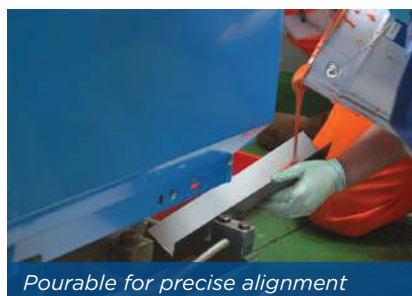
Pourable for precise alignment

Belzona 7111, a 100% solids pourable chocking compound, was developed In 2014. This impact and vibration resistant system is ideal for pouring foundations for heavy equipment and maintaining precise alignment under machinery, ensuring effective load bearing.

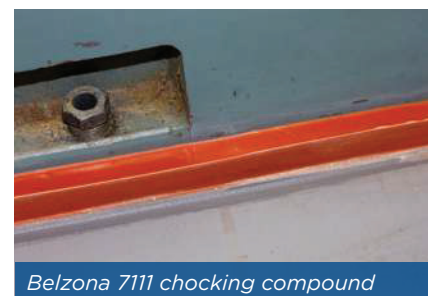
Belzona 7111 chocking compound

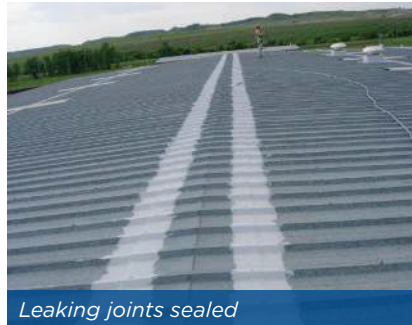
Leaking joints sealed

Movement, loading and weathering can lead to the deterioration of roofing protection. Belzona liquid applied 3000 Series membranes can seal the entire roof or localised leaking areas and adhere to various substrates and geometries. Protection is seamless and moves in sympathy with the substrate, allowing for expansion and contraction. Emergency solutions are also available, which can be applied directly onto wet surfaces.

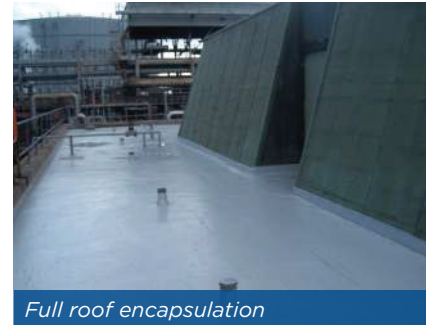
Full roof encapsulation

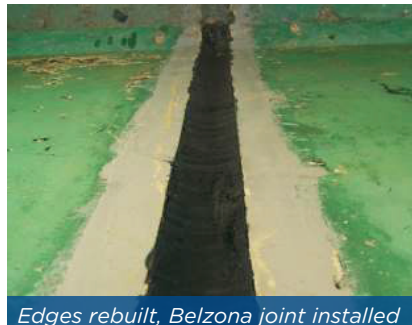
Edges rebuilt, Belzona joint installed

Joints and concrete nosings are susceptible to deterioration caused by impact, thermal cycling, mechanical and chemical attack. Belzona 2000 Series Elastomers are used to recreate expansion joints but allow for even greater movement due to their excellent elongation.

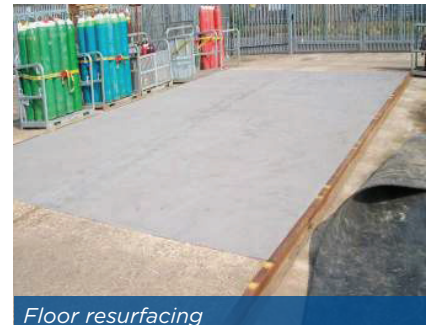
Floor resurfacing

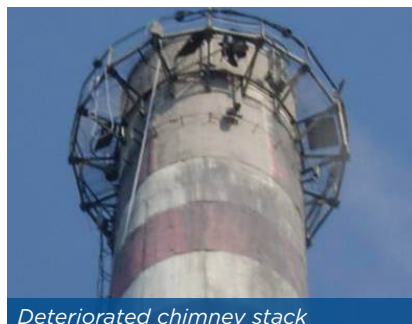
Deteriorated chimney stack

Walls and chimneys suffering from physical, bacterial and chemical attack, as well as water ingress, can be protected with Belzona 5000 Series coatings. Our range of wall coatings provides excellent UV protection and their smooth surface does not attract dirt and will 'self-clean' during rain fall.

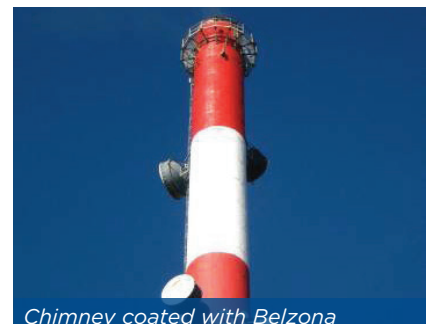
Chimney coated with Belzona

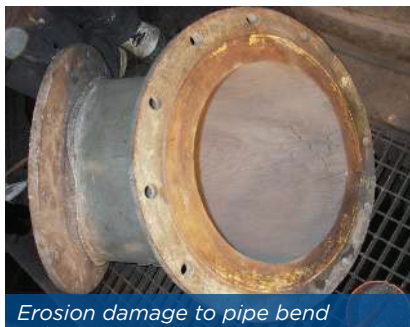
Erosion damage to pipe bend

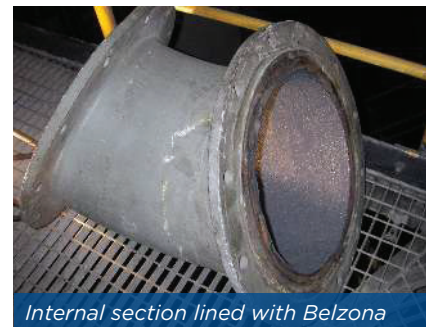
Internal section lined with Belzona

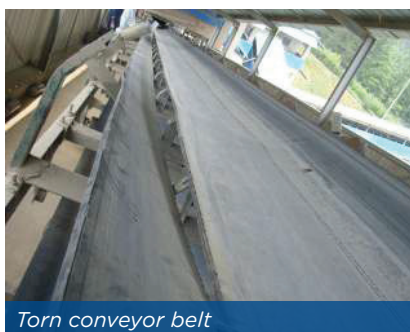
Torn conveyor belt

Due to general wear, tear and heavy abrasion, conveyor belts regularly become worn, ripped or torn. Belzona Elastomers are ideal for the in-situ repair of conveyor belts without the need to disassemble the equipment. These flexible materials can be applied without the need for specialist tools, vulcanisation or heat and will adhere to almost any surface. They provide excellent resistance to wear, abrasion and atmospheric degradation and, in addition, offer high elasticity and exceptional mechanical strength.

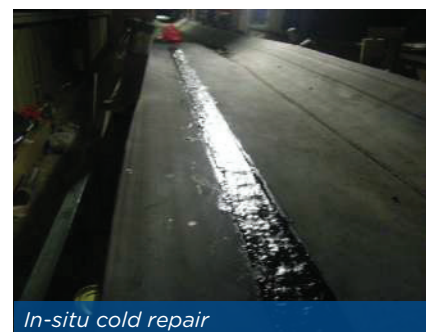
In-situ cold repair

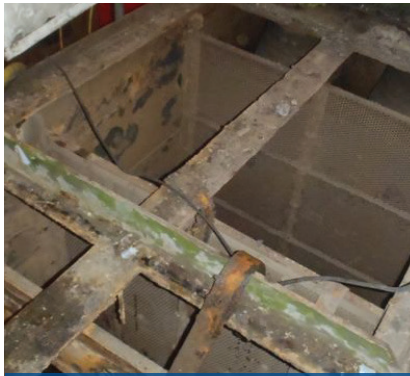
Eroded rubber lined tanks

Due to the highly corrosive and erosive environments encountered in the nuclear power industry, many vessels are rubber lined in order to protect the steel surface from abrasion damage. Damage to this rubber lining can allow abrasive solids or corrosive fluids to come into direct contact with the steel shell of the vessel leading to corrosion damage. Belzona 2100 Series of durable abrasion resistant elastomers are commonly used to repair damaged rubber linings, extending the life of the equipment. Localised repairs or complete tank relining can be achieved using these cold applied materials.

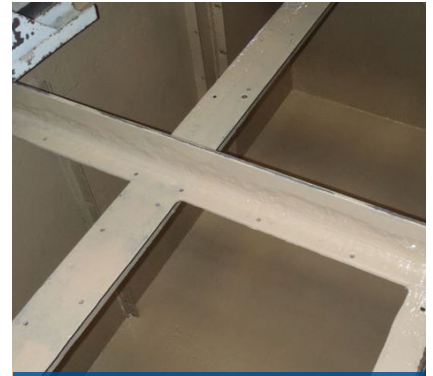
Immersion coating applied

Tanks can be relined with a Belzona coating which provides outstanding corrosion and chemical resistance and protects equipment for the long term.
