MAINTAINING ASSET INTEGRITY IN THE WATER AND WASTEWATER INDUSTRY

Belzona Protective Coatings and Engineering Composites

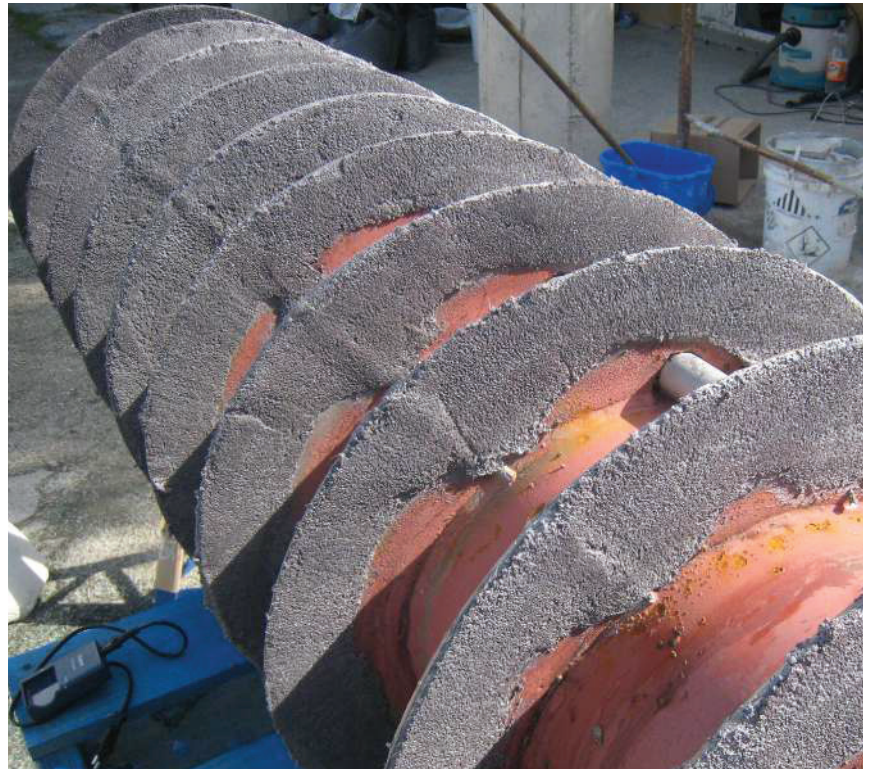
Belzona abrasion resistant coating extends the life of screw conveyor

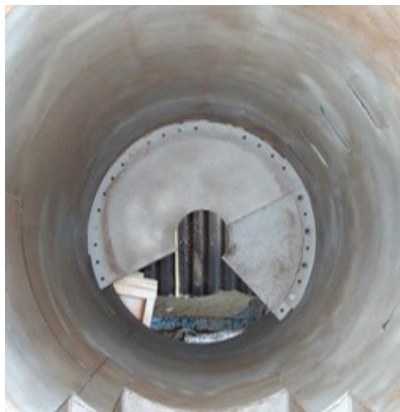
Thin-wall defects on mixer

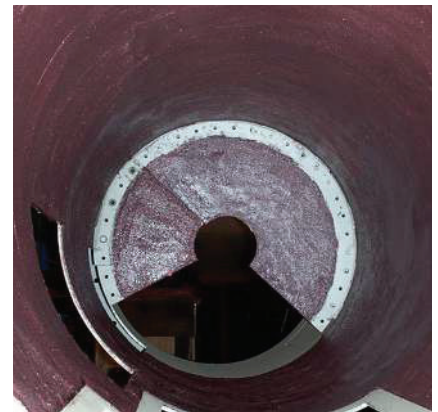
Rebuilt and protected against abrasion

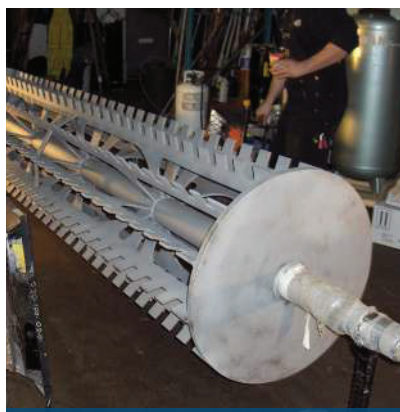
Aerator taken out of service

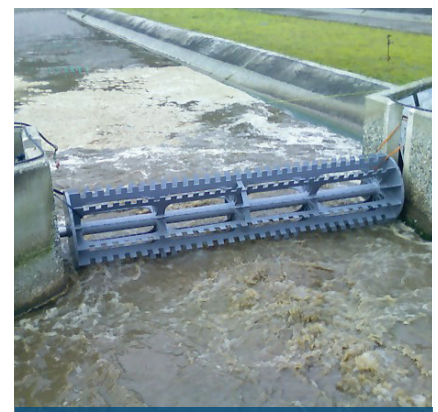
Aerator protected with Belzona coating

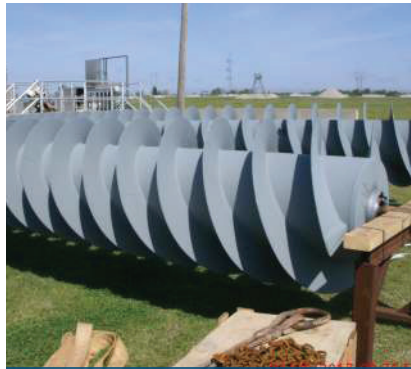
Screw conveyors prior to coating

The efficiency of a screw conveyor, determined mainly by the clearance between the tray and the screw, can be negatively affected by wear and abrasion caused by the solids being handled. Belzona's abrasion resistant materials are commonly used to rebuild the damaged areas and protect against future wear, increasing the performance of the conveying system. Belzona systems are specified based on the nature of the solids handled, as well as the operating temperature.

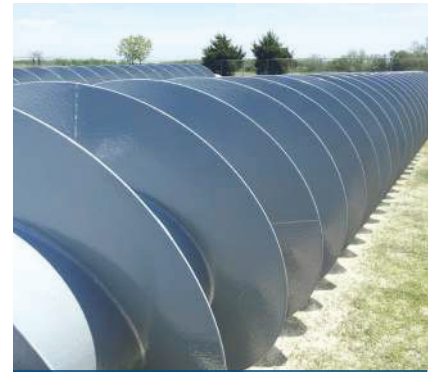
Erosion resistant coating applied

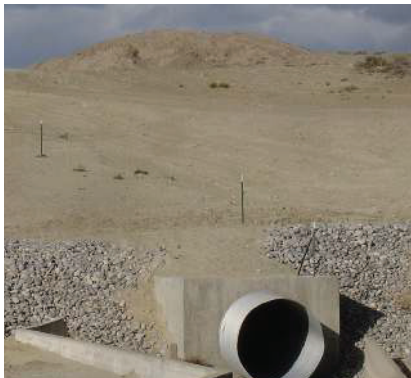
Pipe used to carry irrigation water

Pipe elbows are subject to severe abrasion and wear, especially on the inner surface of the outer circumference of the bend. This is due to the change in direction of the abrasive material which can cause excessive downtime across the whole system.

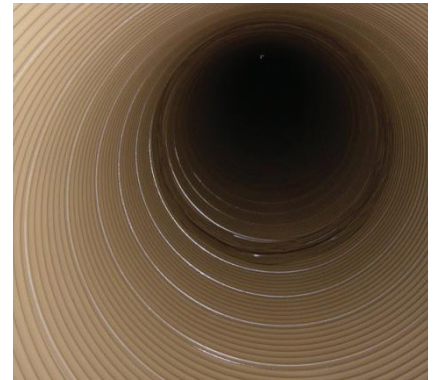
Spray applied internal coating applied

Belzona 1800 Series materials can be used in combination with Belzona alumina tiles to line the bend. If the metallic surface needs reinforcing due to holes or excessive loss of wall thickness, Belzona cold bonding technology can be performed in situ with a paste grade material, eliminating the need for hot work.

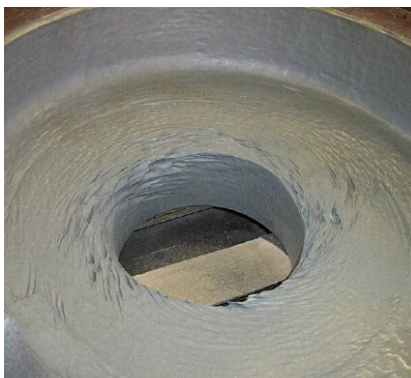
Entrainment damage on slurry pump

Abrasion damage to the internal surfaces of slurry pumps can significantly shorten their service life. Coating the pump with a Belzona sacrificial lining ensures that the pump will stay in service for longer. Rubber linings can also be applied or localised repairs performed with Belzona 2000 Series polyurethanes.

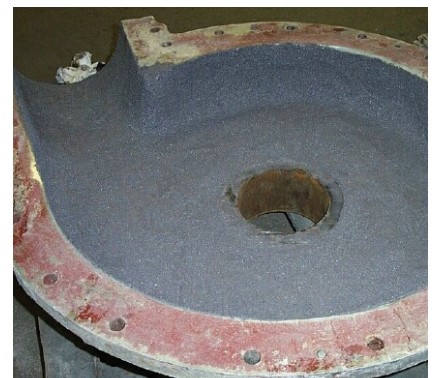
Abrasion resistant coating applied

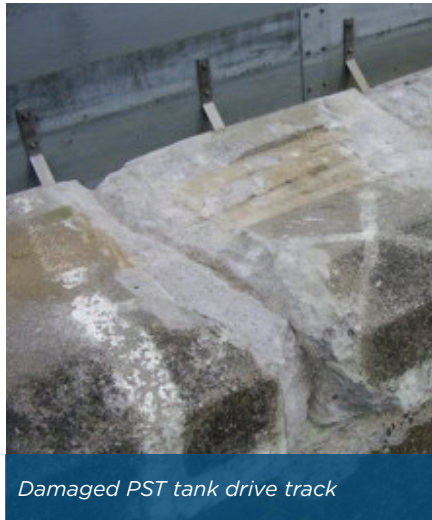
Damaged PST tank drive track

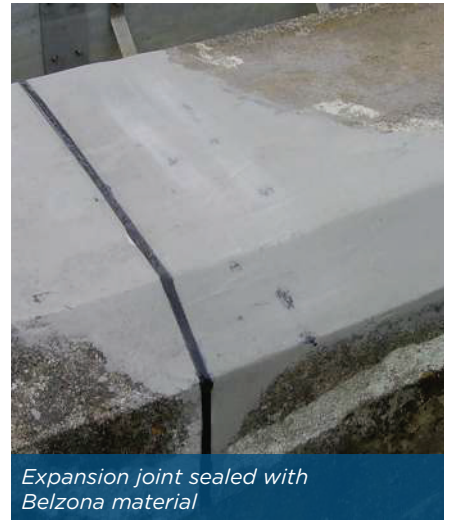
Expansion joint sealed with Belzona material

Through the use of Belzona elastomers it is possible to rapidly repair and seal expansion joints. High elasticity solutions can be cold applied and do not shrink during cure. Their excellent bond strength provides the ultimate long-term seal that can be applied to a range of surface materials such as concrete, natural rubber, nitrile, neoprene, SBR, polyurethane, PVC and steel.

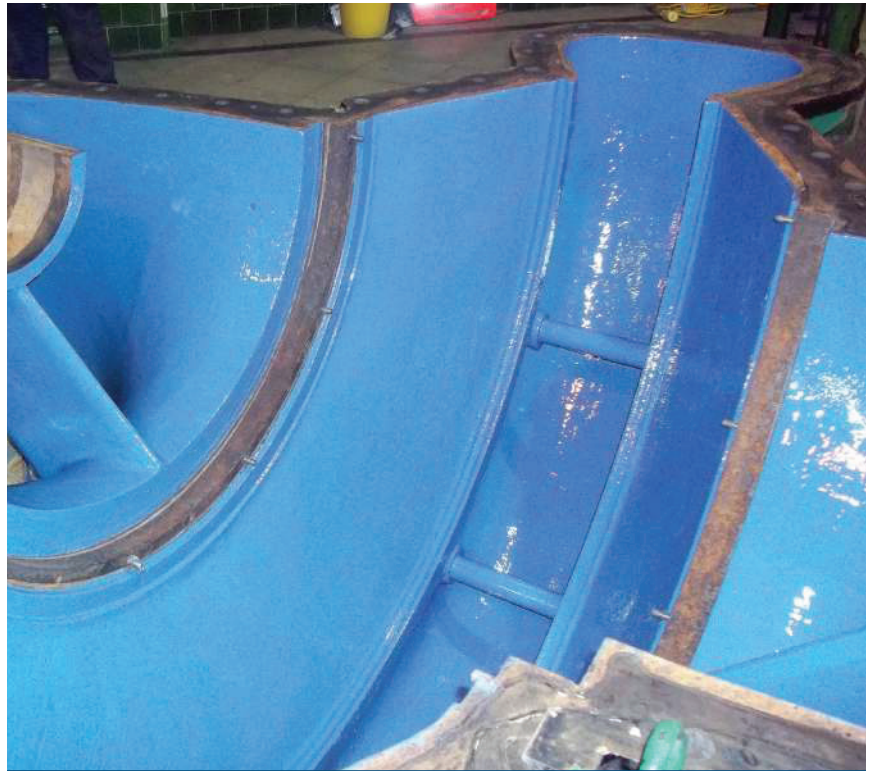
Pump internals coated with Belzona materials for long-term corrosion protection

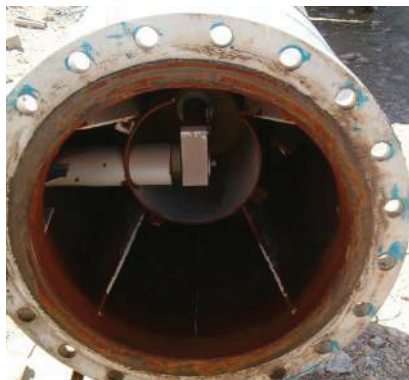
Corrosion and erosion on internal surfaces caused by sewage water

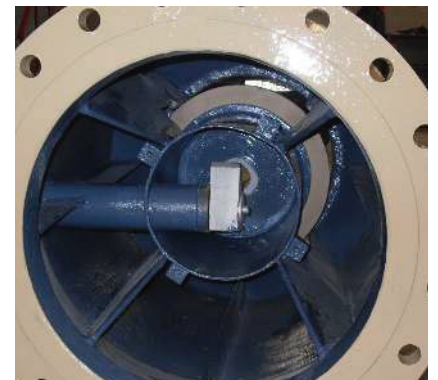
Internal surfaces rebuilt and protected with Belzona coating

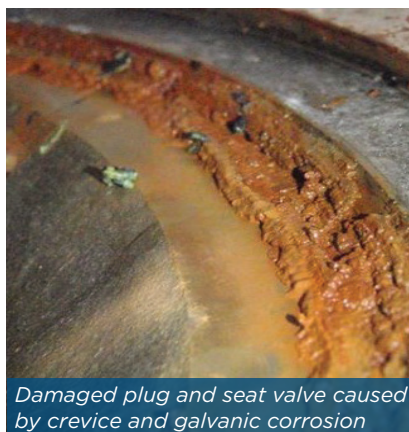
Damaged plug and seat valve caused by crevice and galvanic corrosion

Erosion-corrosion is a problem which affects most valves due to the environments in which they operate coupled with the operating regime which can induce impingement and cavitation damage. Belzona materials can be used to rebuild and re-profile the valve bodies and coat and protect from further erosion-corrosion damage.

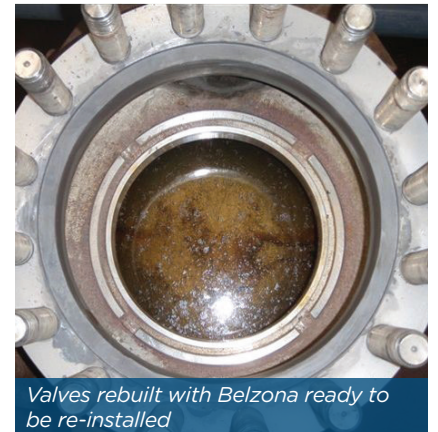
Valves rebuilt with Belzona ready to be re-installed

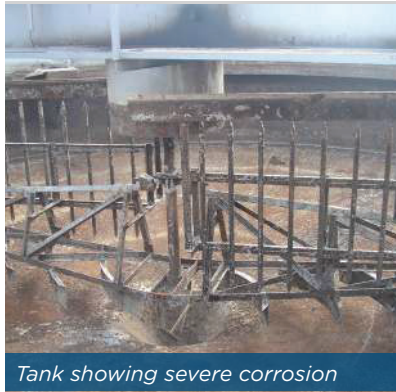
Tank showing severe corrosion

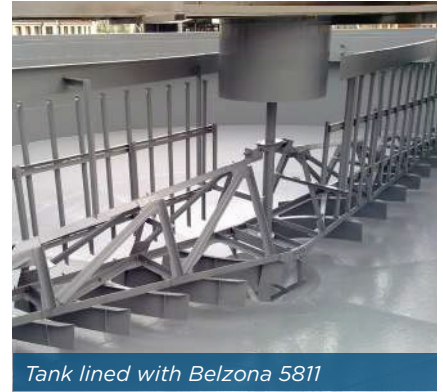
Tank lined with Belzona 5811

Belzona 4311 (Magma CR1) is designed to protect secondary containment areas against chemical attack, whilst Belzona 5811 (Immersion Grade) can protect surfaces subjected to constant or regular immersion in aggressive liquid environments.

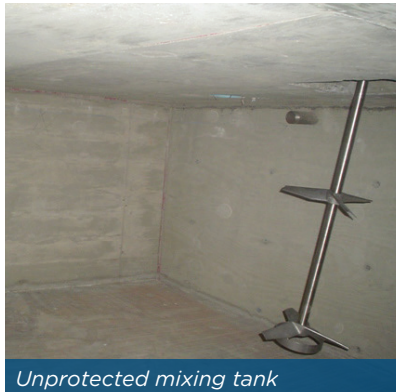
Unprotected mixing tank

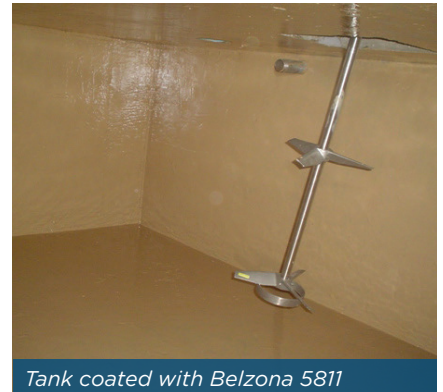
Tank coated with Belzona 5811

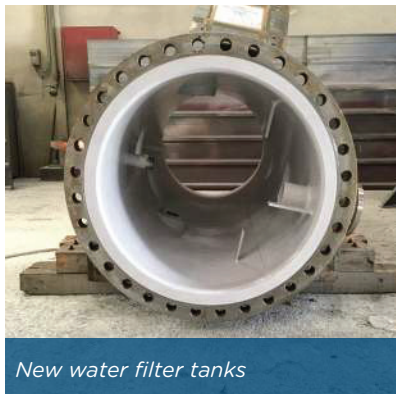
New water filter tanks

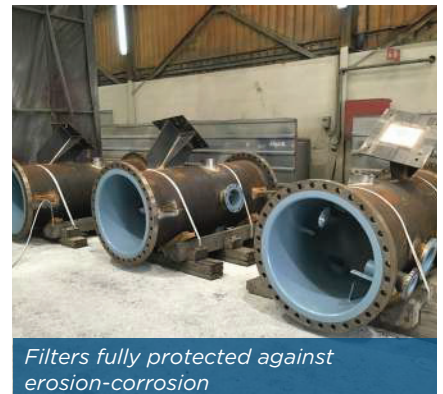
Filters fully protected against erosion-corrosion

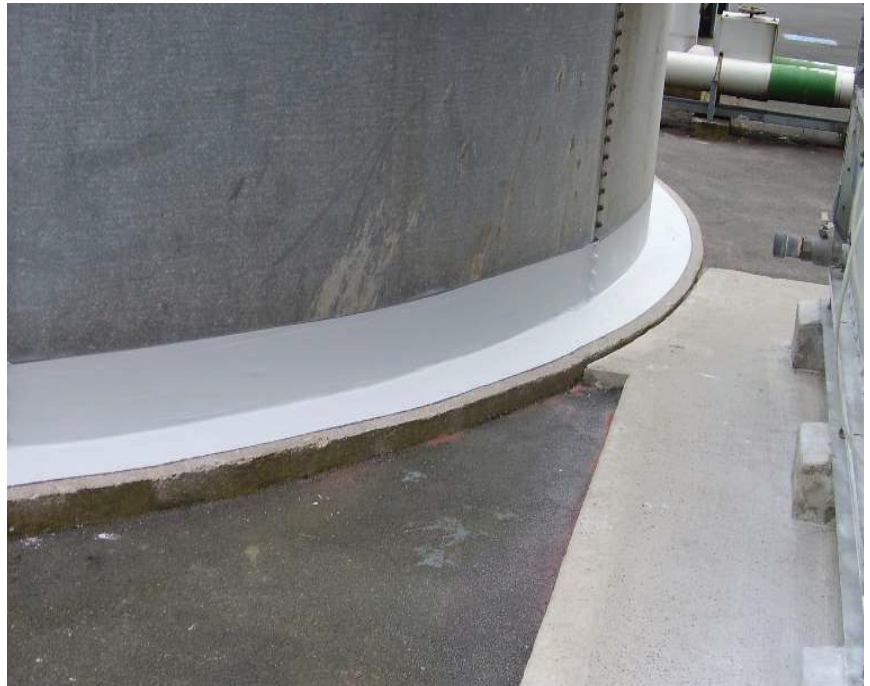
Belzona lining applied to a newly fabricated process vessel

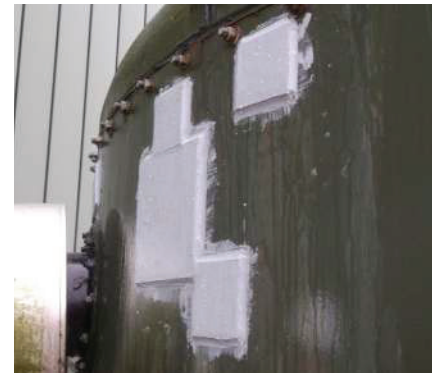
Tank repaired by cold bonding

Tank walls can also suffer from corrosion and leaking welds. Belzona repairs can be carried out on-line with the use of cold bonded doubler plates or a reinforced composite system.

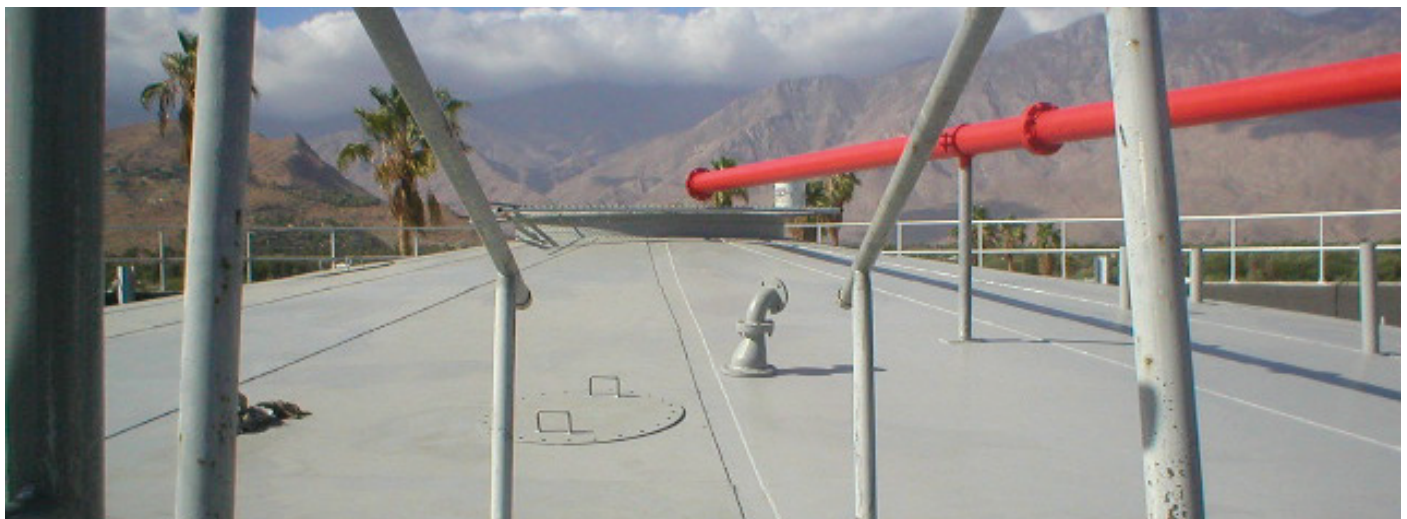
Tank roof restored with a Belzona protective coating

Tank roofs are susceptible to rapid deterioration caused by the corrosive vapour of the storage media and is exacerbated by external forces. Roof damage can be safely repaired in situ and on-line, eliminating the need to drain the tank.

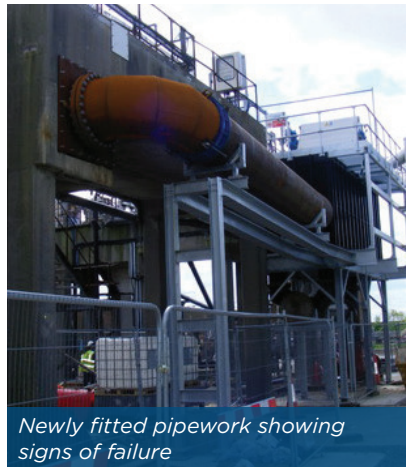
Newly fitted pipework showing signs of failure

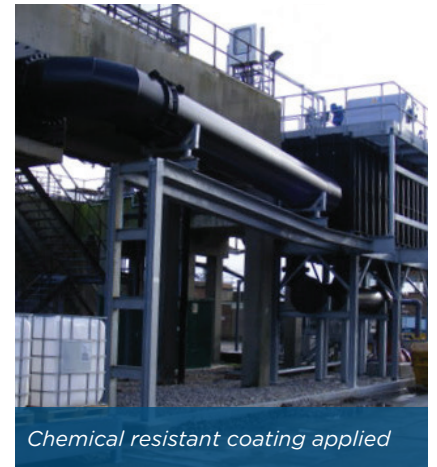
Chemical resistant coating applied

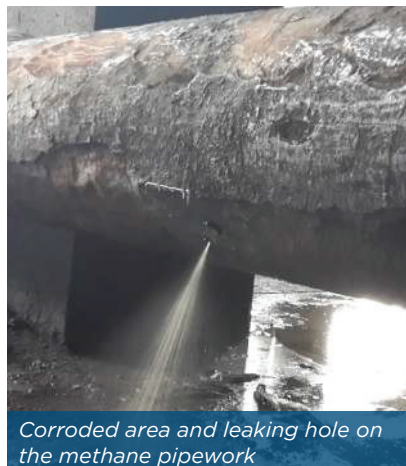
Corroded area and leaking hole on the methane pipework

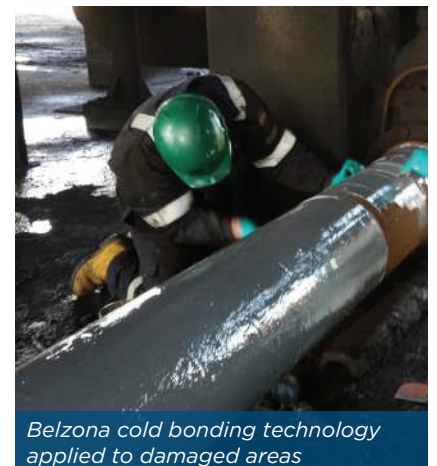
Belzona cold bonding technology applied to damaged areas

There is a variety of solutions that can help to repair, restore and protect pipework and flanged components from these threats. Thin- and through-wall defects caused by external corrosion can be repaired using a Belzona wrap system or a simple cold plate bonding technique.

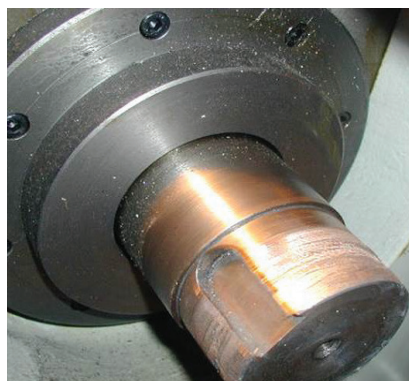
Damaged keyway housing and scored shaft

Keyways become worn and oversized due to constant pressure from starting and stopping, causing vibration, misalignment and stress on couplings. Belzona epoxy composite materials are designed to repair and prevent these common failures to mechanical power transmission equipment. Using a new key as a former, a perfect zero-tolerance fit is created. This simple repair saves time and money, while quickly returning the equipment to operation.

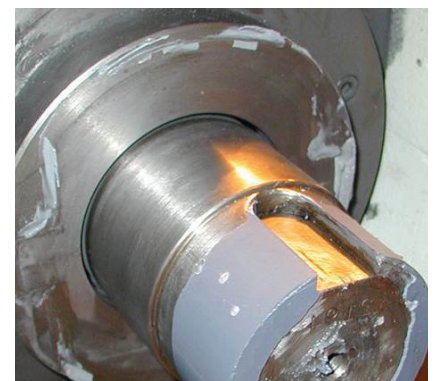
Keyway housing and shaft repaired with Belzona material

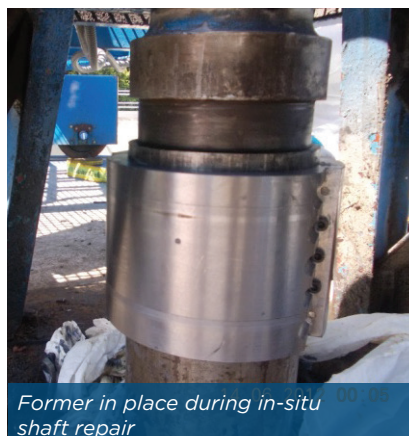
Former in place during in-situ shaft repair

Shafts become worn and damaged due to vibration, friction, abrasive contaminants and corrosion. Where it is impractical to strip a shaft, Belzona metallic polymers can repair in situ without the risks that result from welding procedures.

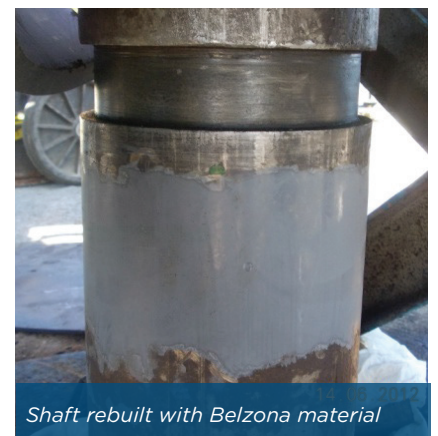
Shaft rebuilt with Belzona material

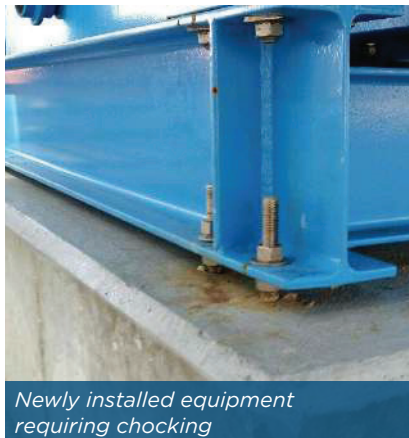
Newly installed equipment requiring chocking

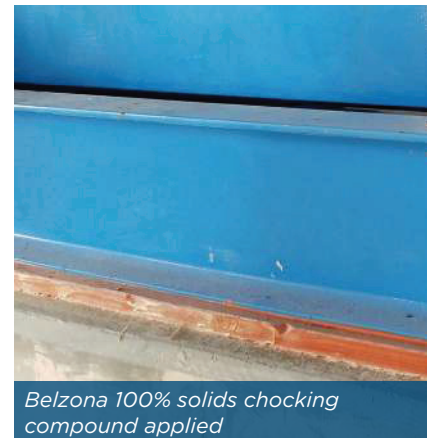
Belzona 100% solids chocking compound applied

Belzona chocking compound provides exact alignment per its non-shrinking properties, whilst its high impact and compressive strength provides high load bearing capabilities.

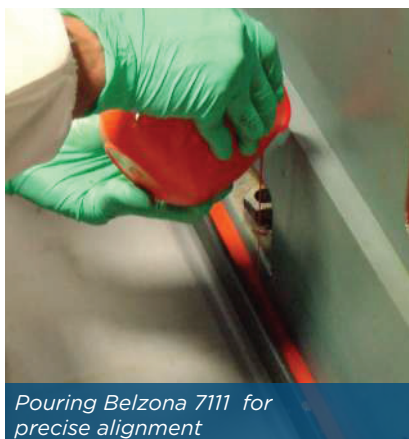
Pouring Belzona 7111 for precise alignment

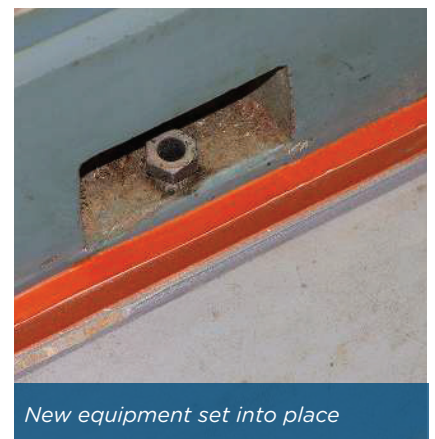
New equipment set into place
